V.I. Inspections

1238 NW 126th St

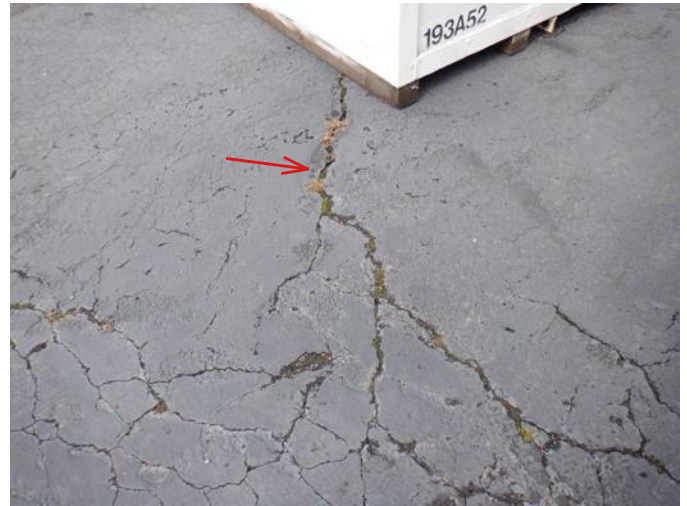
#2 Sections of driveway surface cracked.

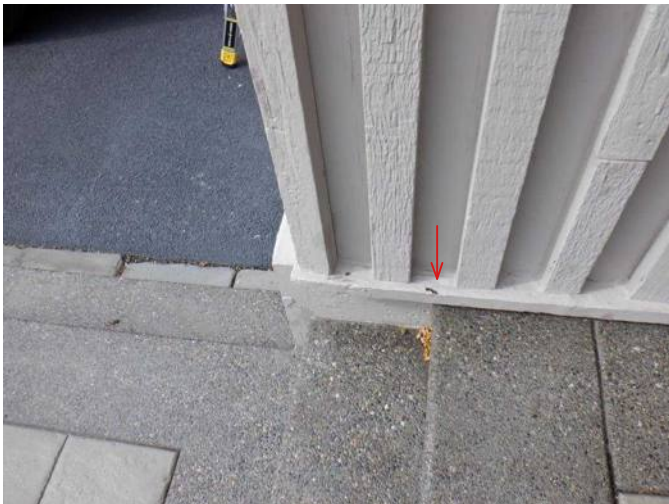
#3 Minor paint peeling in trim work.

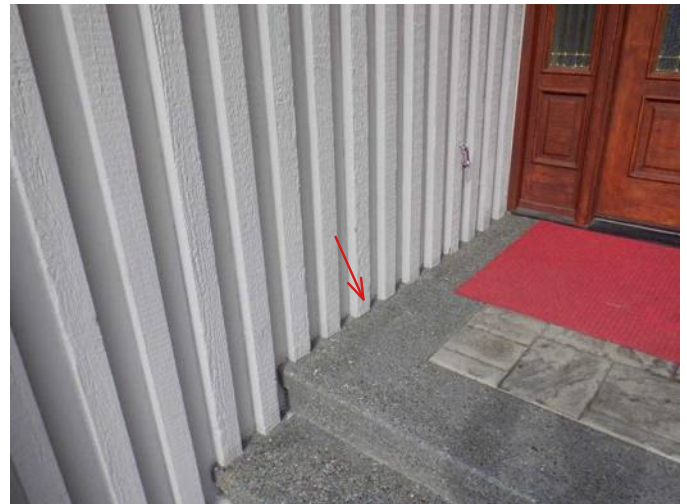
#4 Siding/trim in contact with front porch cement.

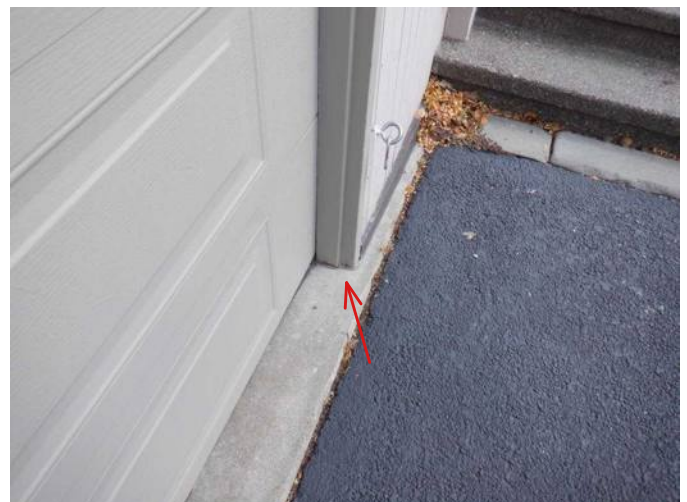
#6 Garage door trim in contact with cement.

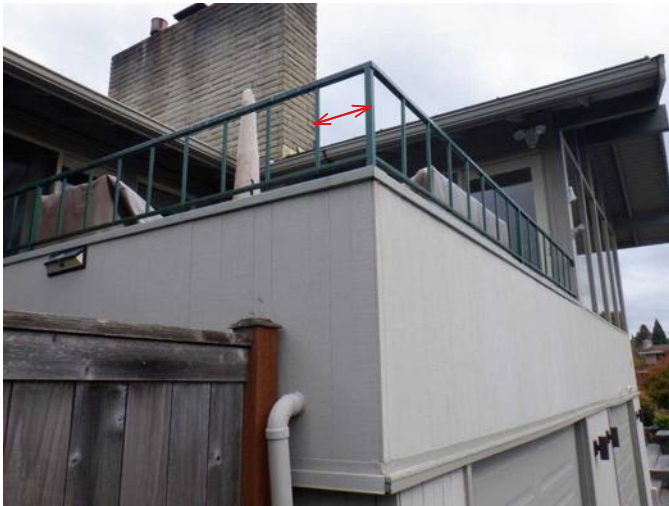
#7 Baluster spacing too wide on both balconies (safety).

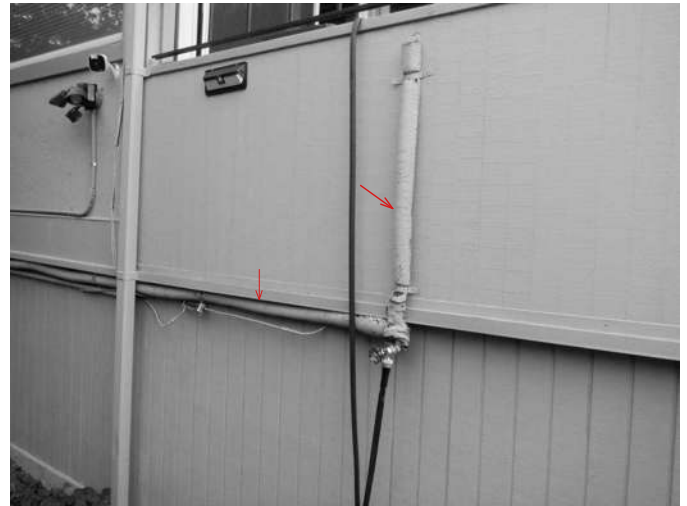
#8 Exterior piped hose bibs should be drained in winter time to prevent freezing.

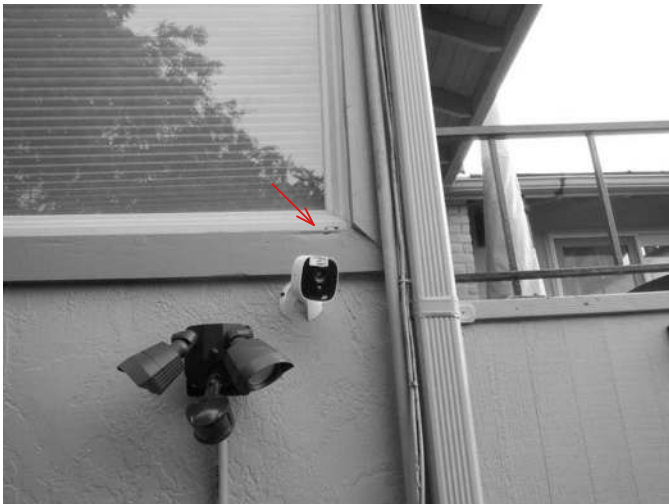
#9 Minor rot in lower SW corner of SW kitchen window trim.

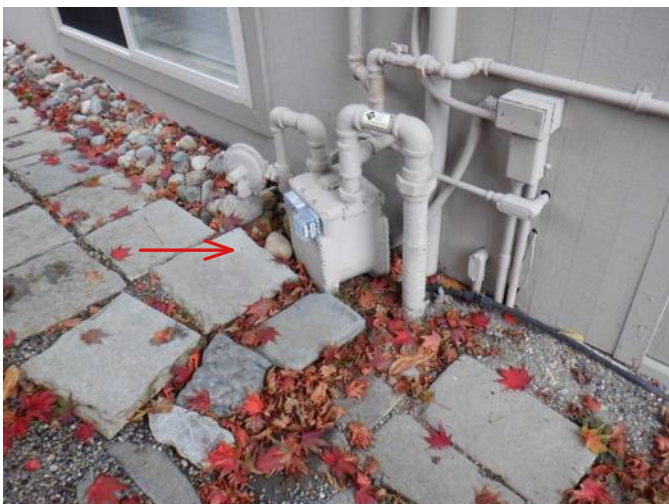
#11 6 inches of air space required under gas meter.

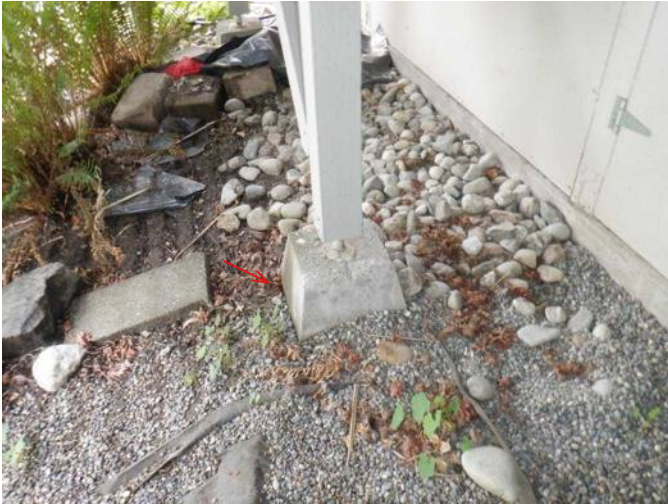
#13 Deck installed on 1X1' pier blocks, should be poured footings.

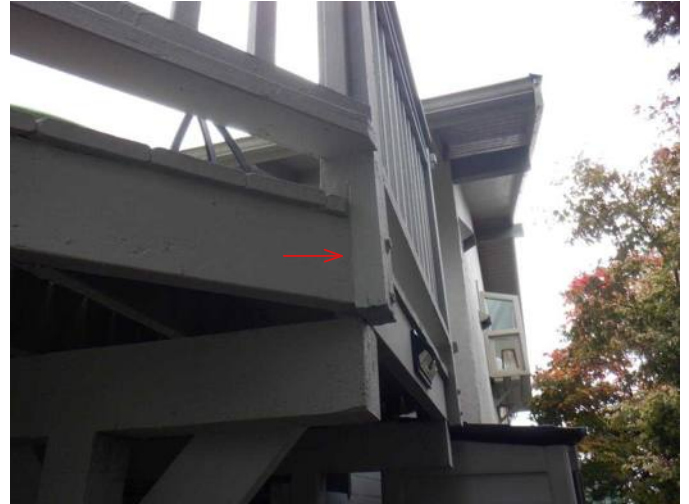
#14 Notched 4x4 railings should be replaced with full 4x4's for increased lateral strength.

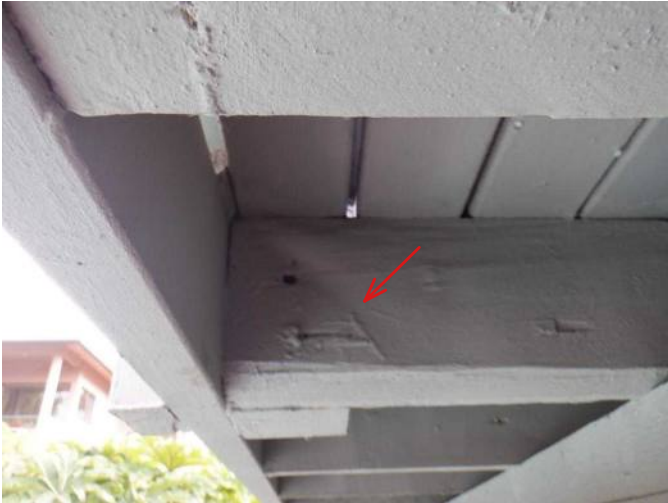
#15 Rot occurring in sections of untreated wood joists in deck system.

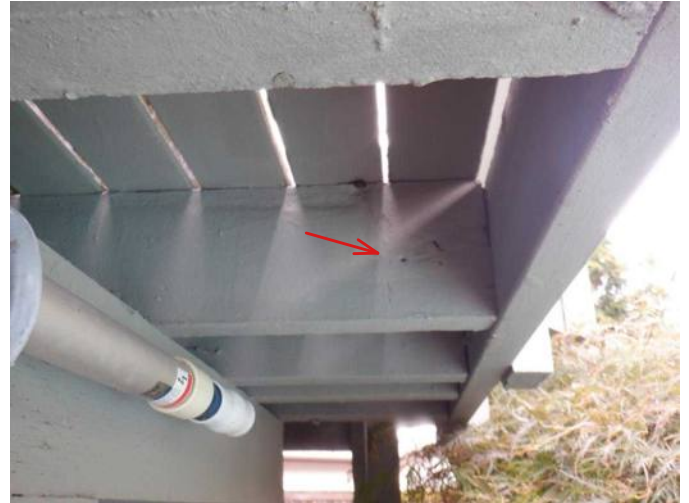
#16 Rot occurring in sections of untreated wood joists in deck system.

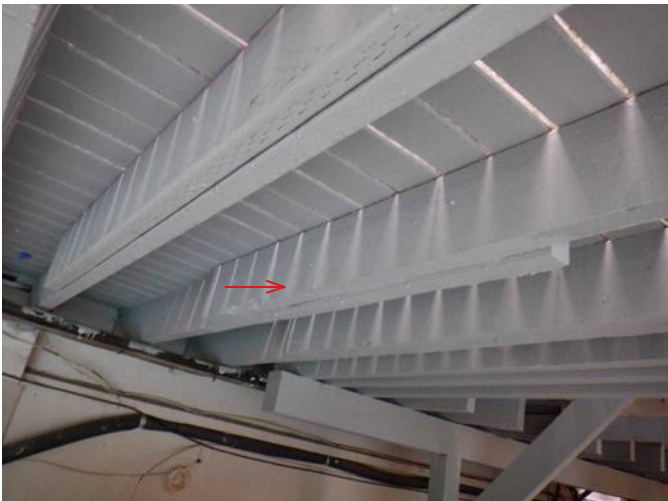
#17 A few joists are sistered mid span, need to be through bolted for stability.

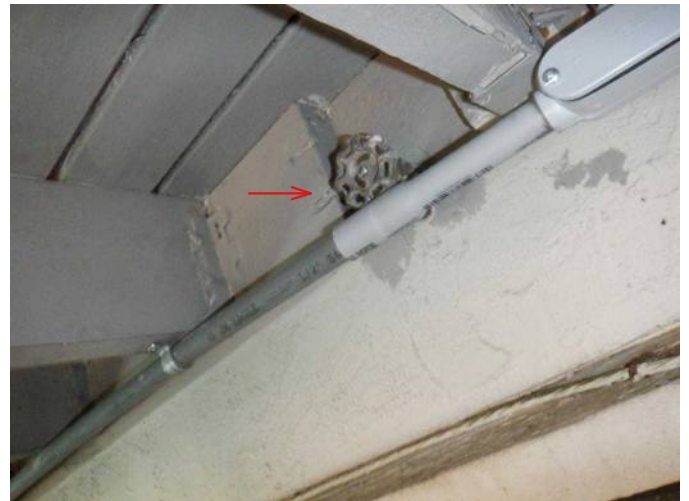
#18 N hose bib appears to have been abandoned.

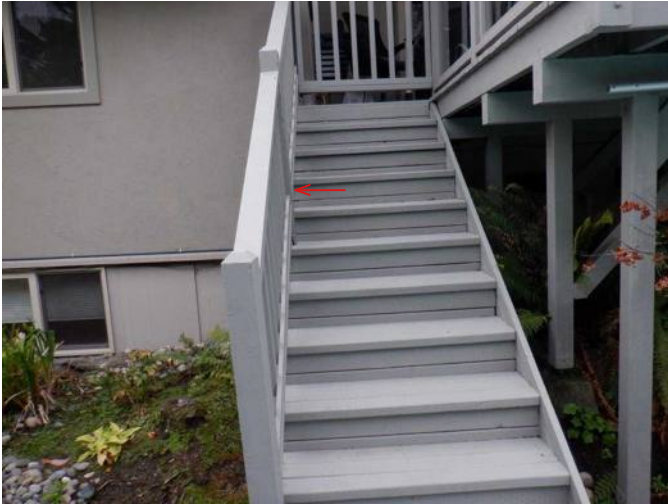
#19 Grasable handrail not installed on deck access steps.

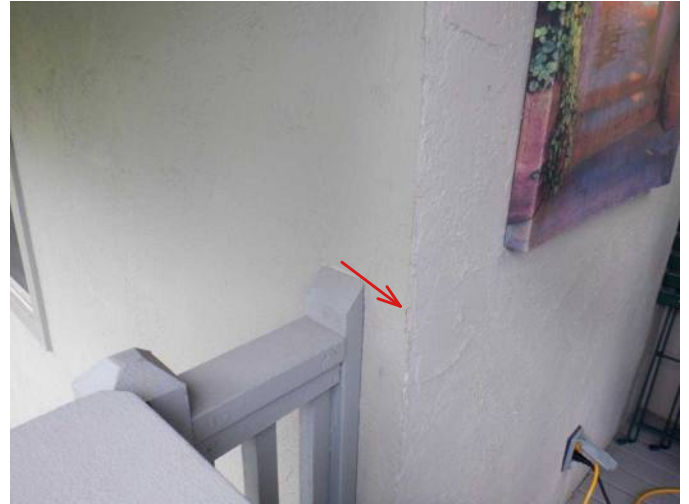
#20 Minor chipping in N stucco, visible on deck.

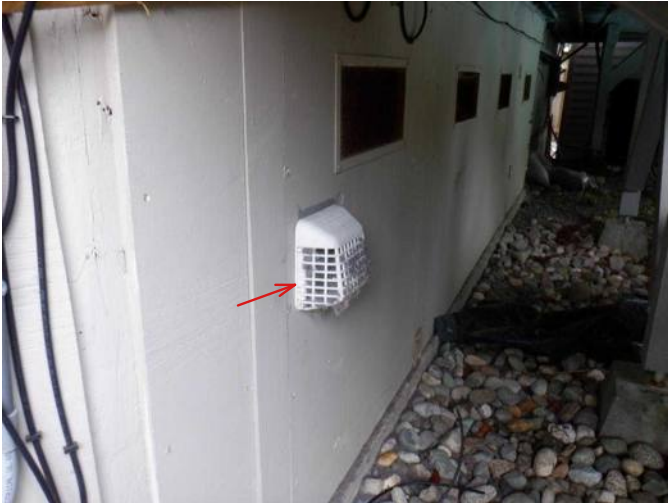
#21 Pest cage installed on exterior of dryer vent will need to be observed and cleaned when needed.

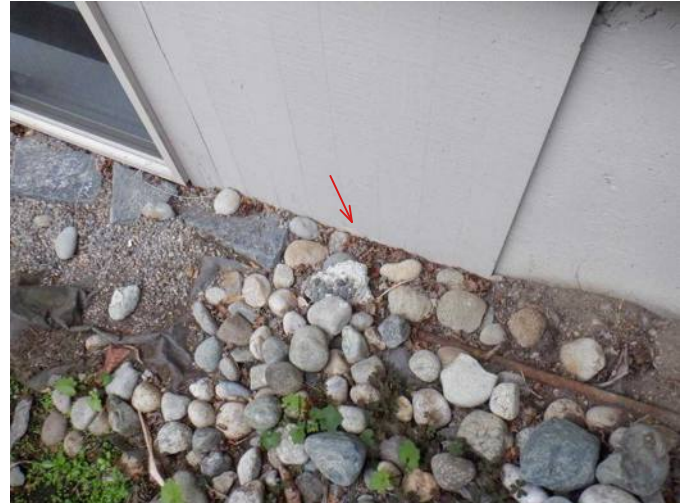
#22 Siding/soil contact along N side of house.

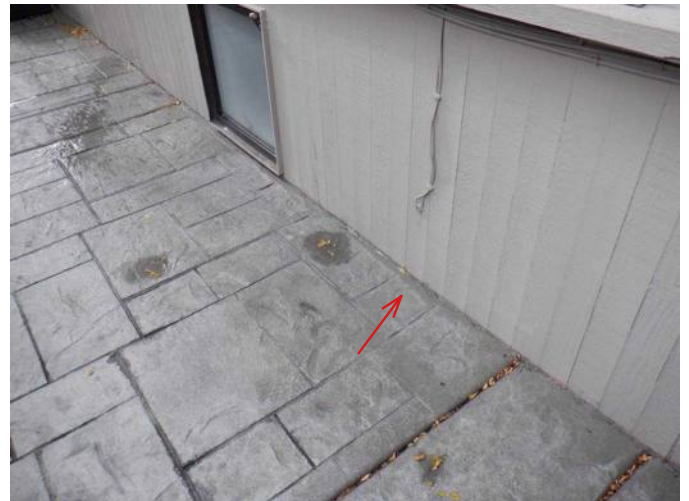
#24 Siding/concrete contact along E side of house.

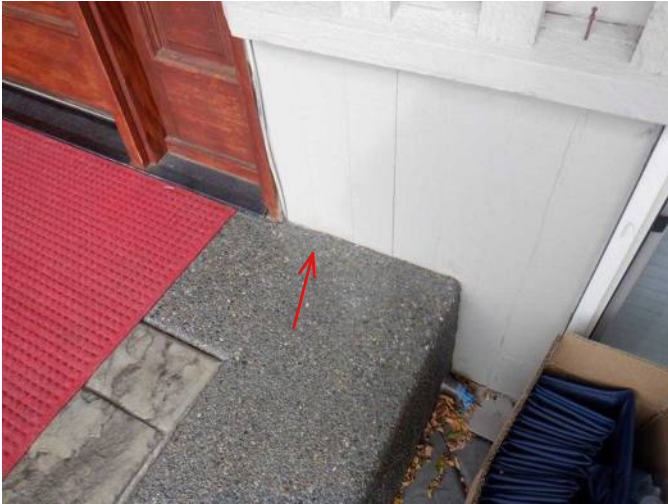
#25 Siding/concrete contact at front porch.

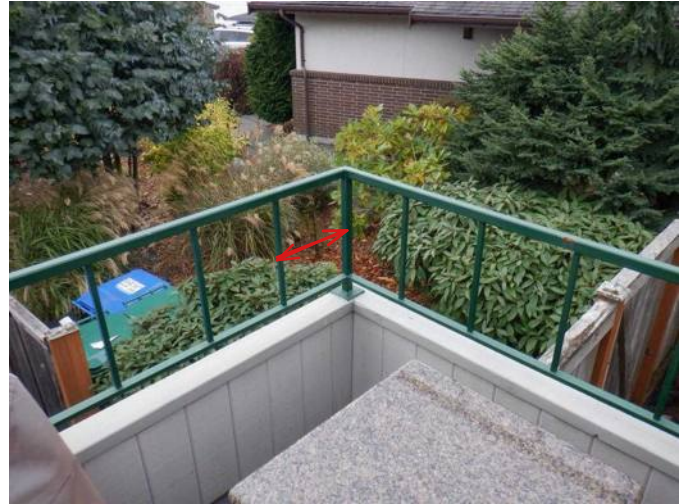
#26 Baluster spacing too wide on both balconies (safety).

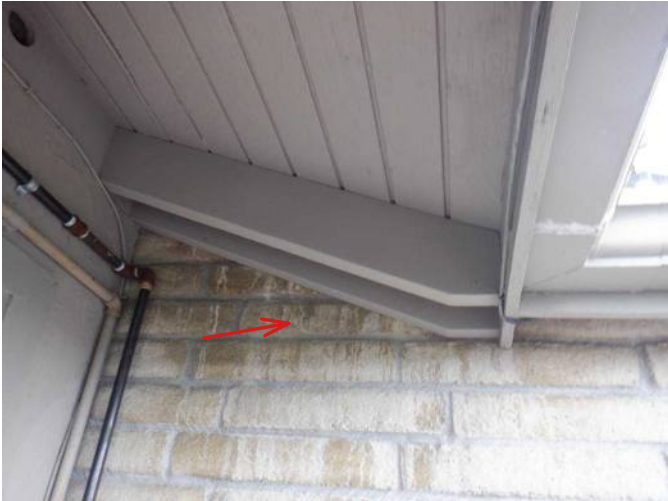
#27 Staining on chimney, at W balcony level, indicates past moisture intrusion.

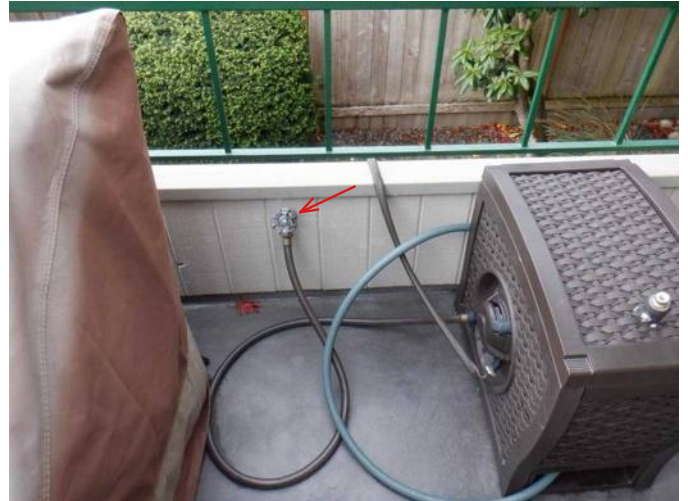
#28 Exterior W and N hose bibs do not have vacuum breakers installed.

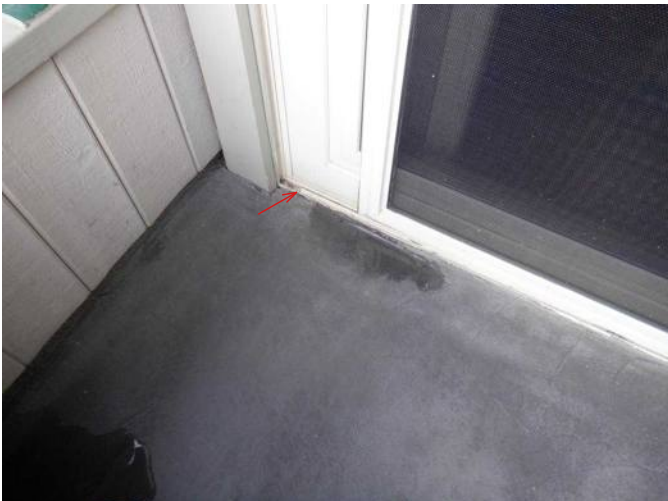
#29 Balcony surface connection to house will need to be maintained against moisture intrusion.

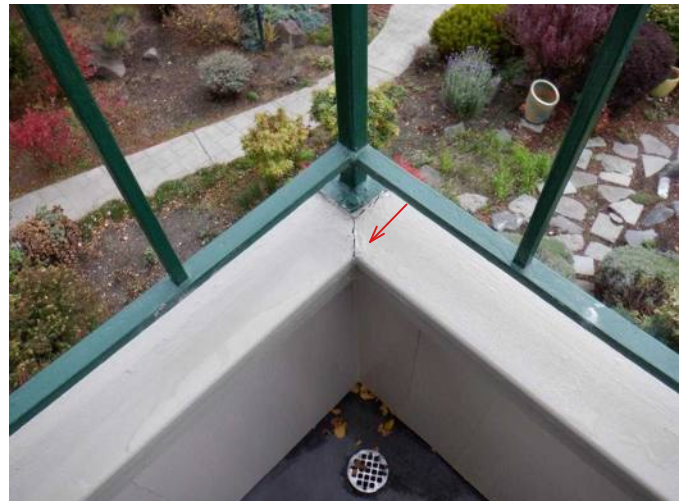
#30 Miter cut in SE balcony top rail needs to be sealed against moisture intrusion.

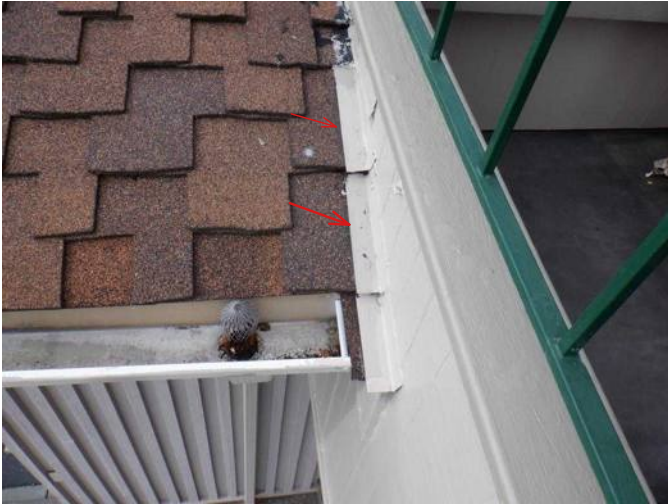
#31 Step flashing at roof/SE balcony junction, installed on top of roof material.

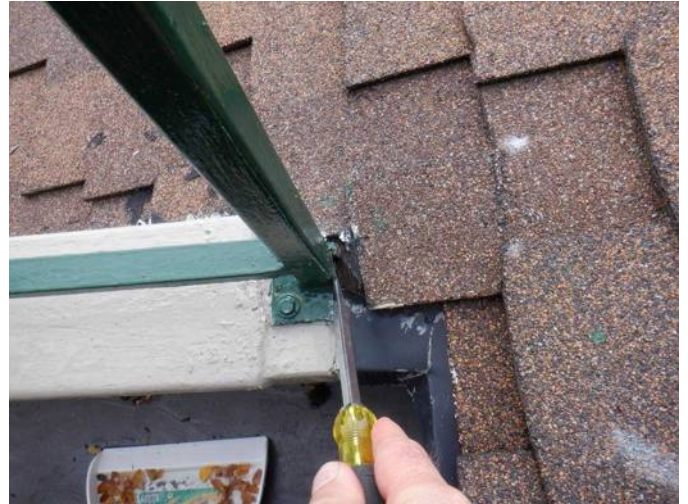
#32 Roof junction with SW corner of SE balcony relying on caulking for weather seal, will need to be maintained.

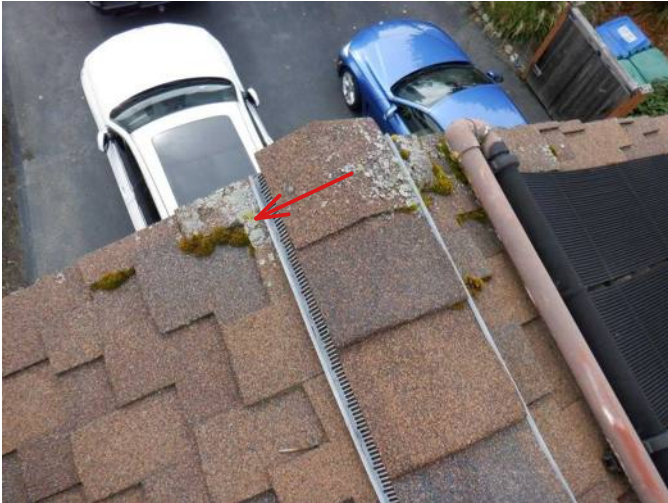
#33 Minor moss build up should be removed and moss will need to be maintained off of roof surface.

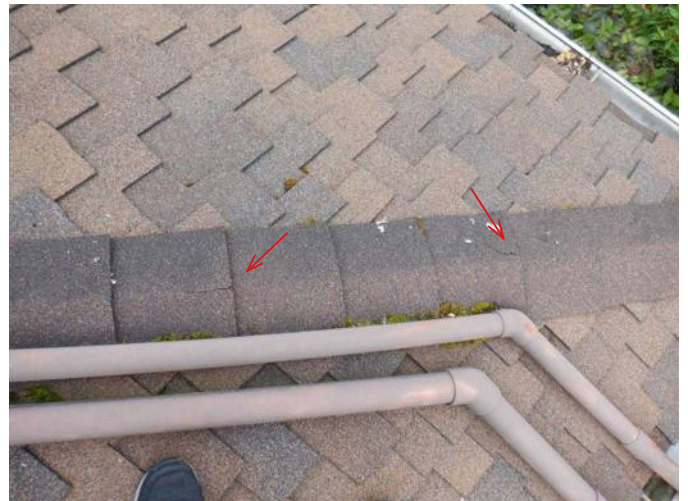
#36 Minor tears in NE hip ridge caps.

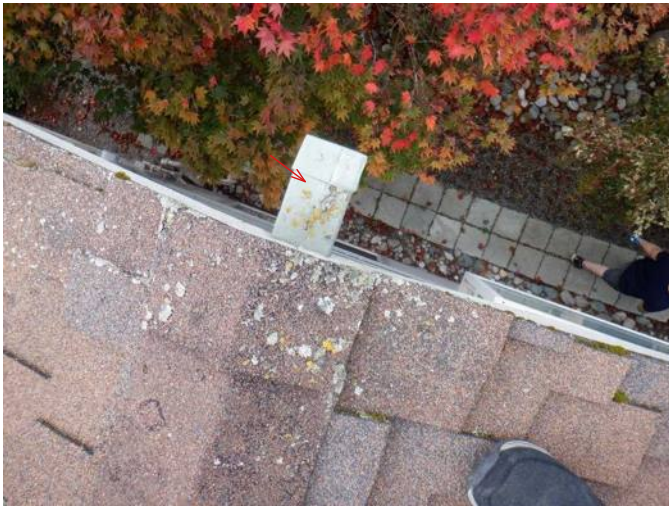
#37 Minor paint peeling in trim work.

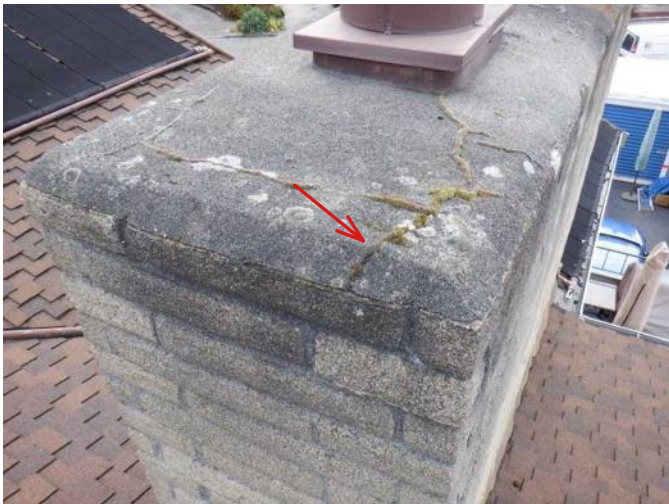
#39 Cracks in crown needs to be sealed against moisture intrusion.

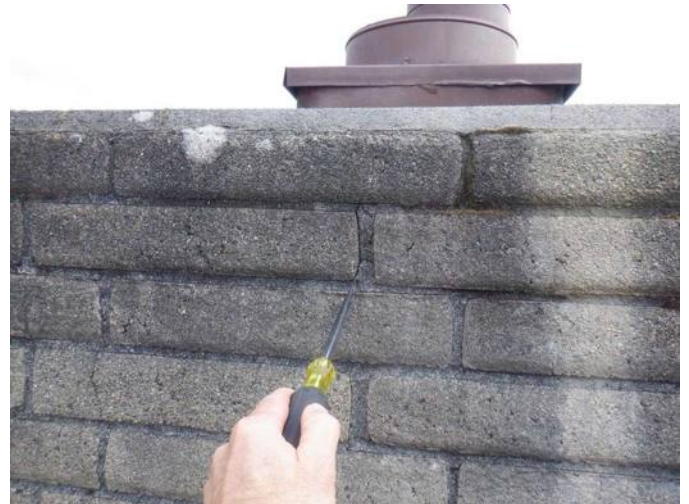
#40 Minor cracks in chimney mortar, need to be sealed.

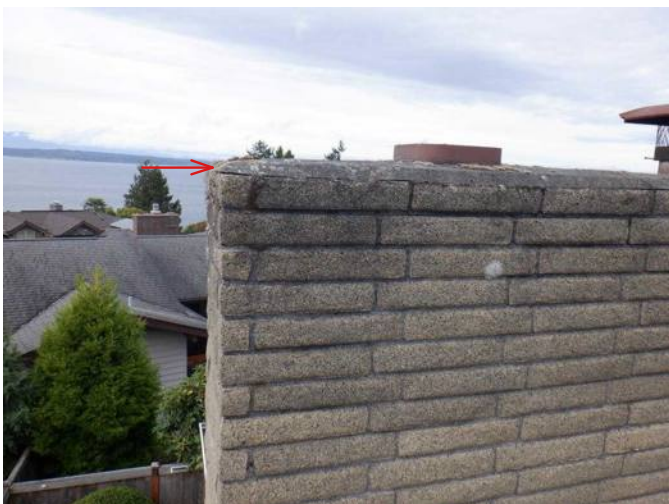
#41 Crown partially detached from chimney.

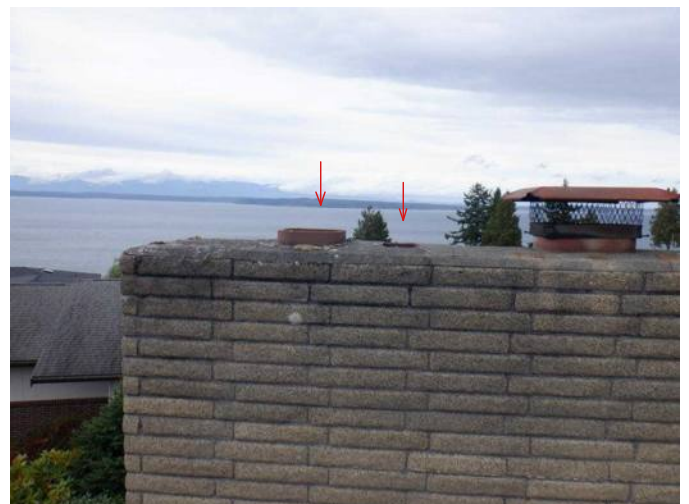
#42 Recommend rain caps be installed.

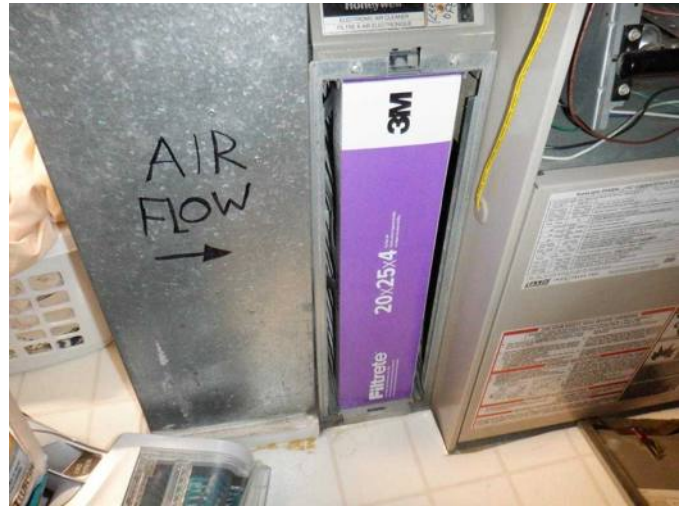
#44 Older electronic air filter for furnace has been abandoned and replaced with disposable paper filter.

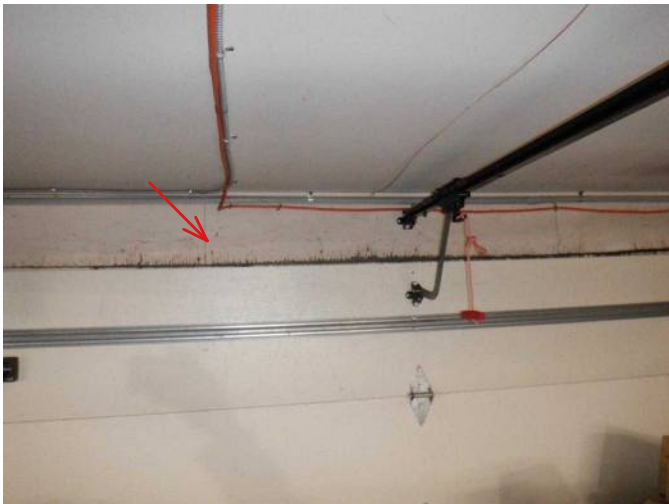
#45 Rot occurring in upper SW wall paneling over W garage door.

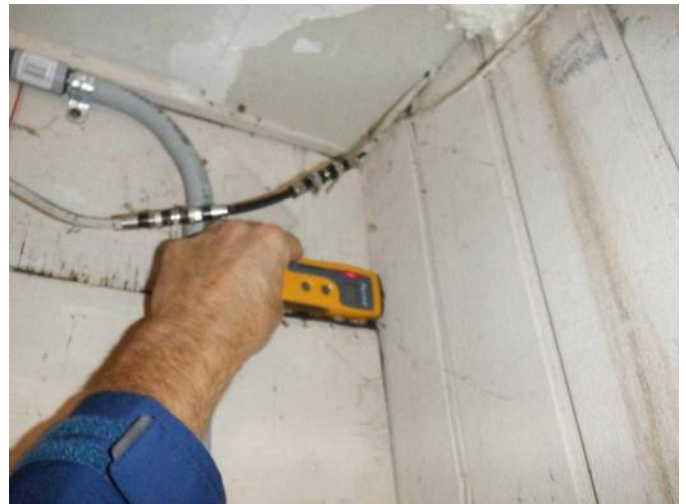
#46 High moisture reading in upper SW corner of garage wall.

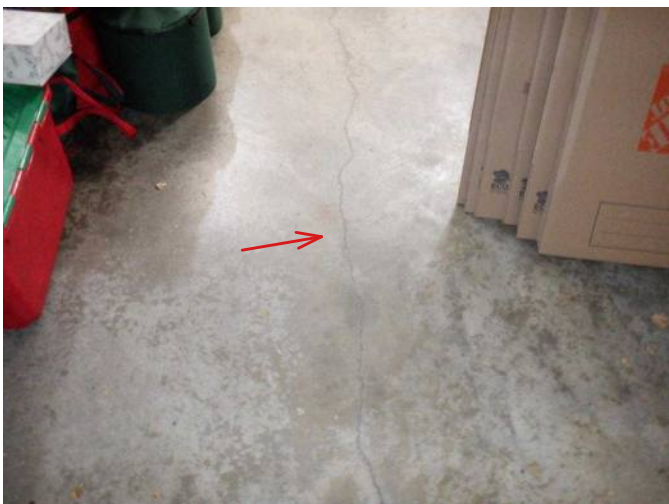
#47 Cosmetic cracks present in garage floor, normal for age of house.

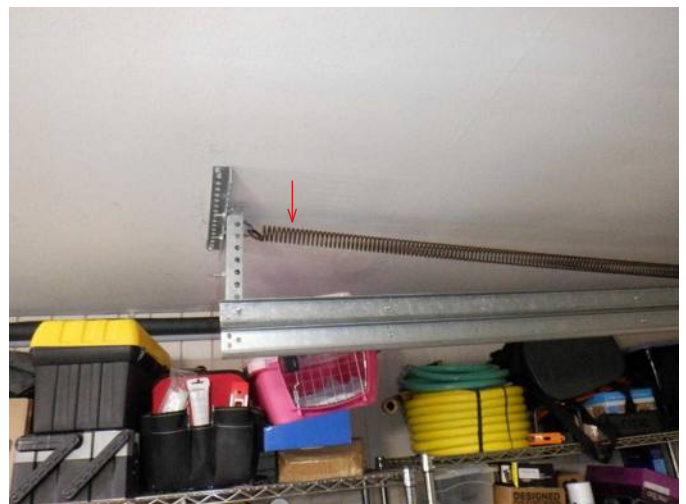
#48 Safety cables are not installed in older door springs for garage doors.

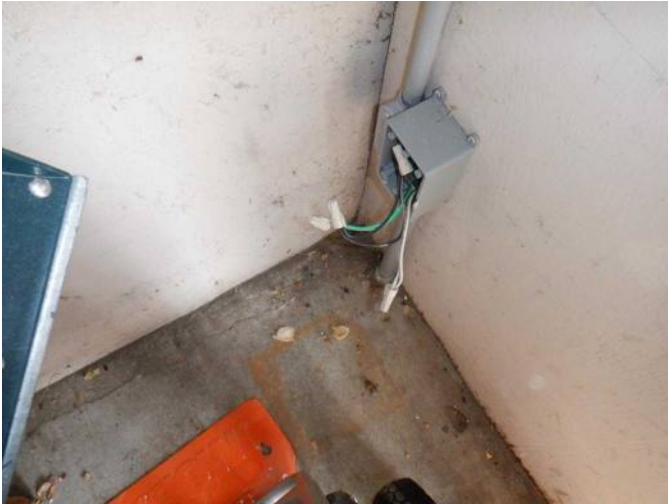
#49 Open junction box in SE corner of garage needs a cover plate.

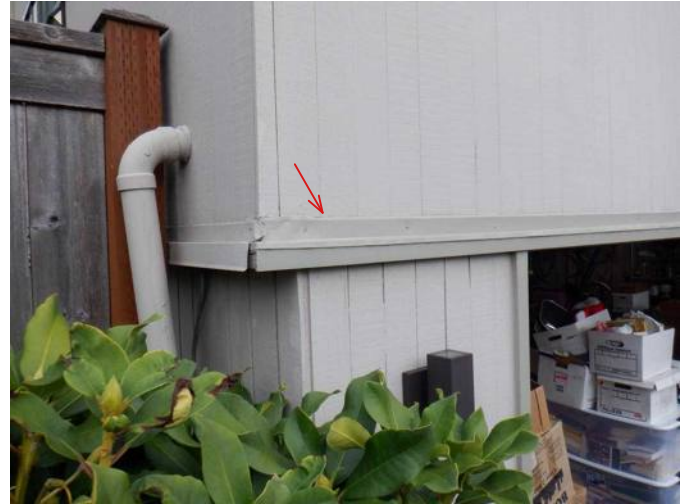
#50 High moisture reading in garage wall at this location.

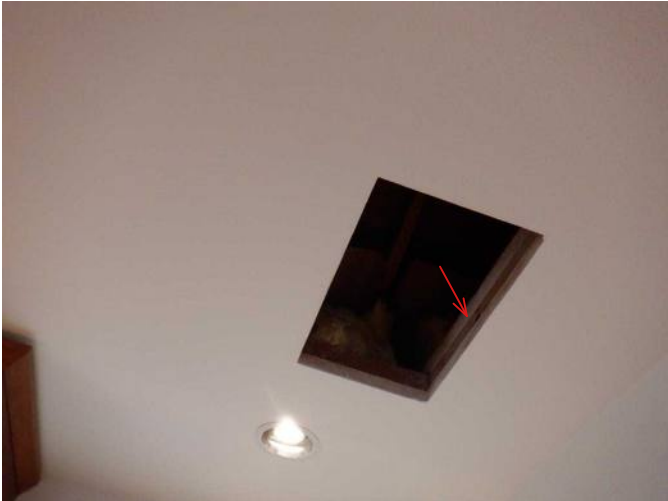
#51 No air seal present for lower attic access hatch.

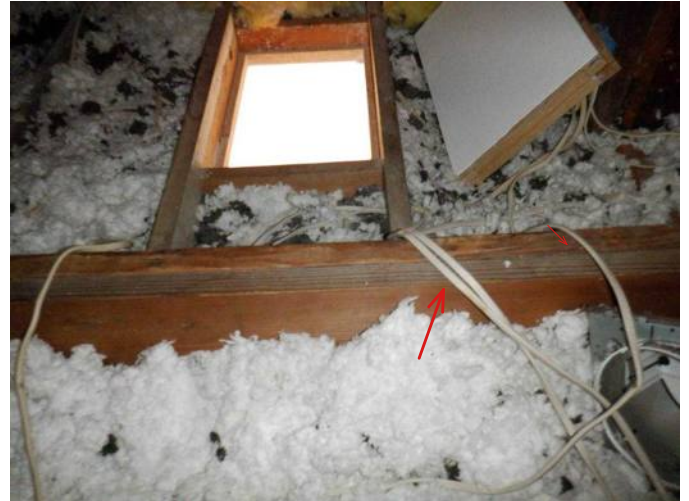
#52 Wiring installed too close to lower attic access hatch (safety).

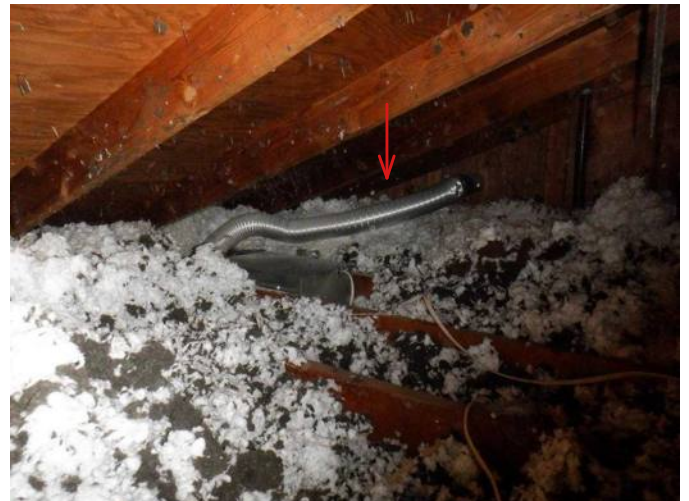
#54 Bathroom fan duct should be insulated in upper attic to reduce condensation build up in fan duct.

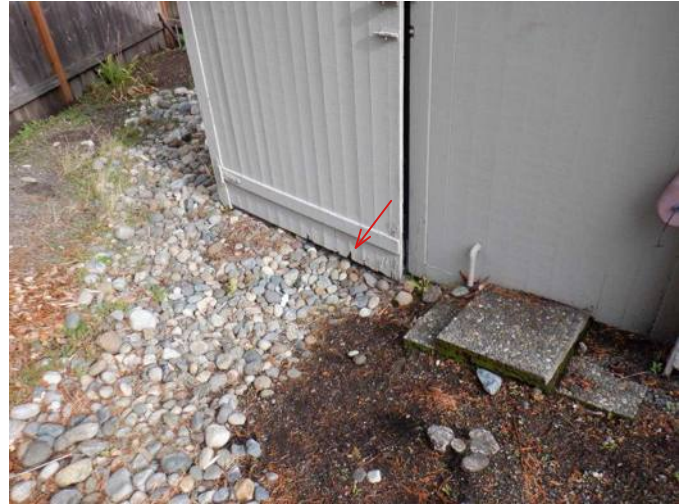
#56 Minor rot occurring along lower edge of access doors.

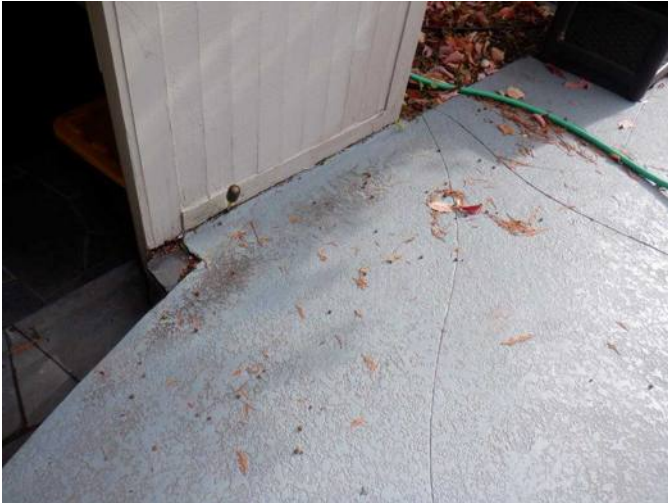
#57 Rot in lower W siding and trim of outbuilding.

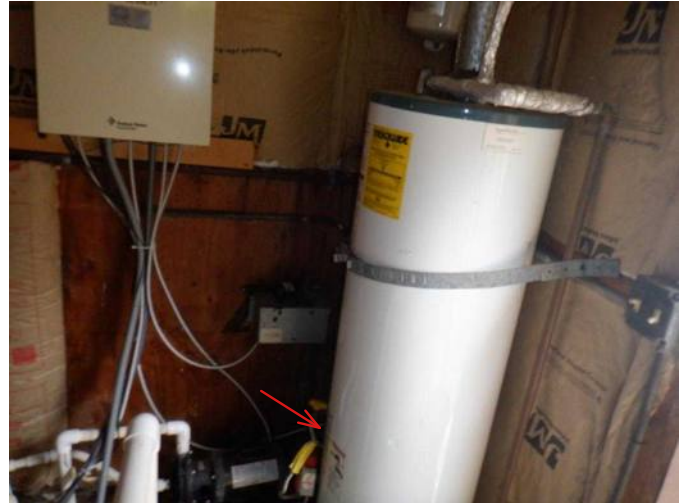
#58 No lower earthquake strap for outbuilding water heater.

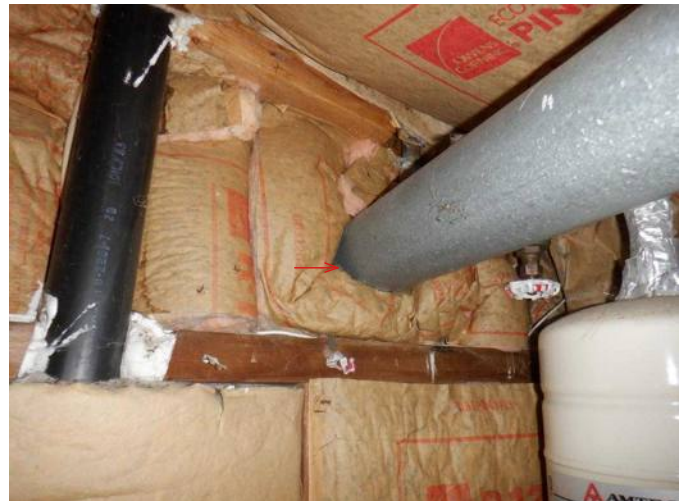
#60 Insulation in contact with outbuilding water heater flue.

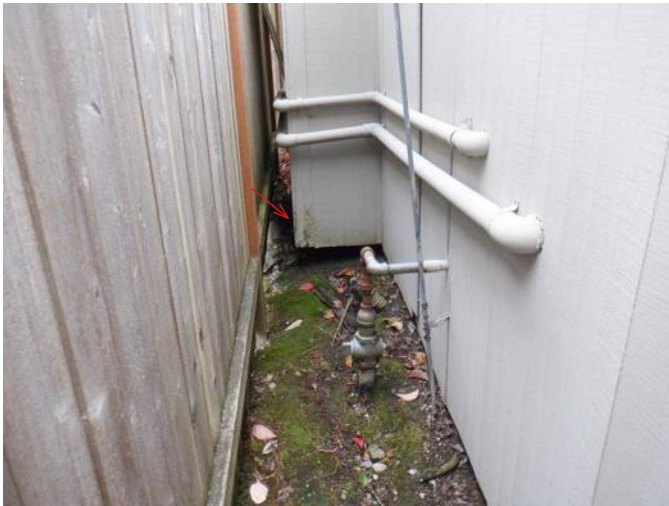
#61 Rot in lower siding of outbuilding.

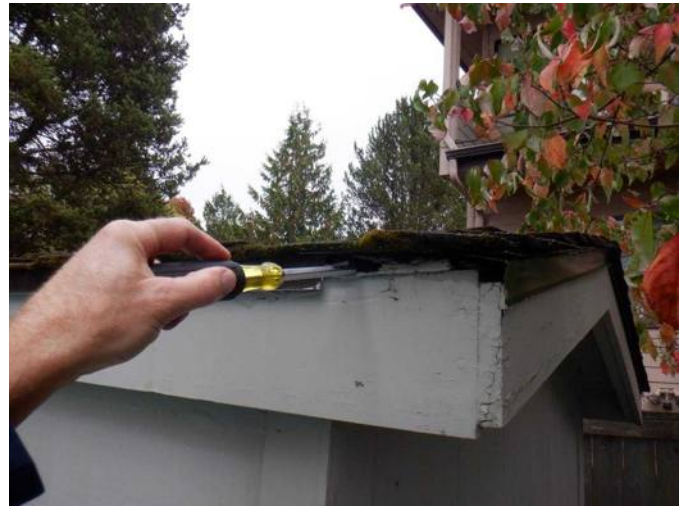
#62 Rot in SW fascia of outbuilding, drip edge flashing not installed.

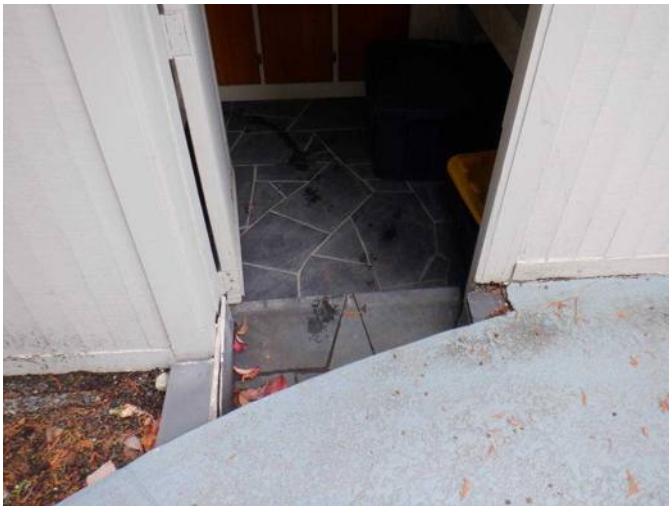
#63 Door to outbuilding bathroom opens over step down, fall hazard.

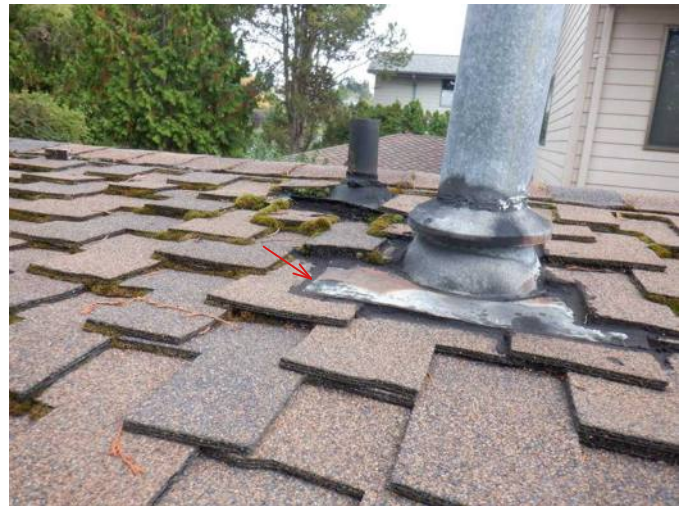
#64 Tar installed around water heater flue and plumbing vent.

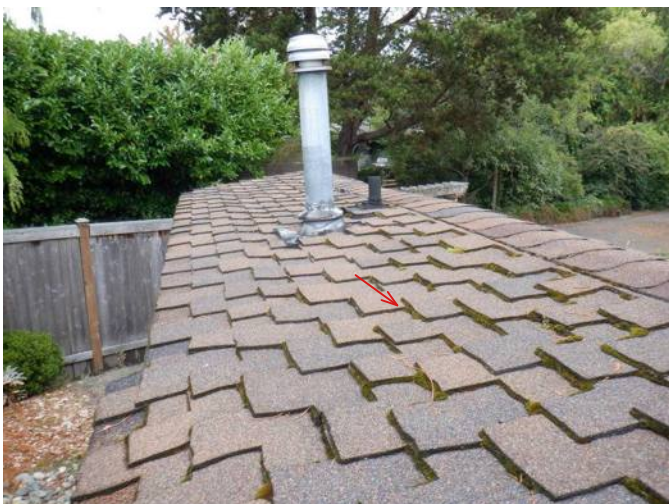
#65 Minor moss build up.

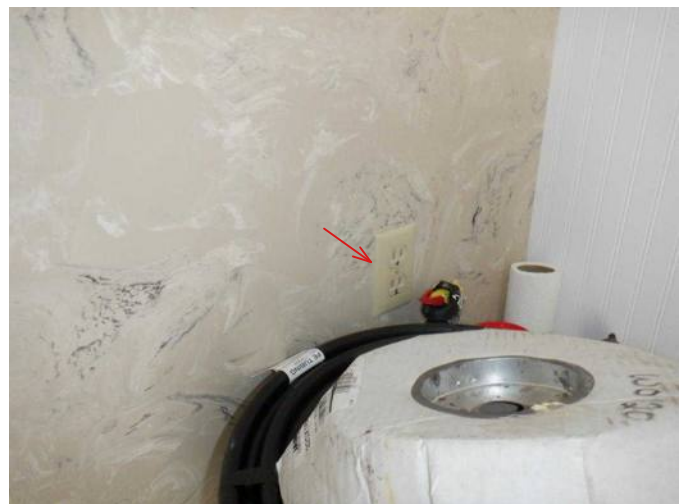
#66 Outlet in outbuilding bathroom is not GFCI protected.

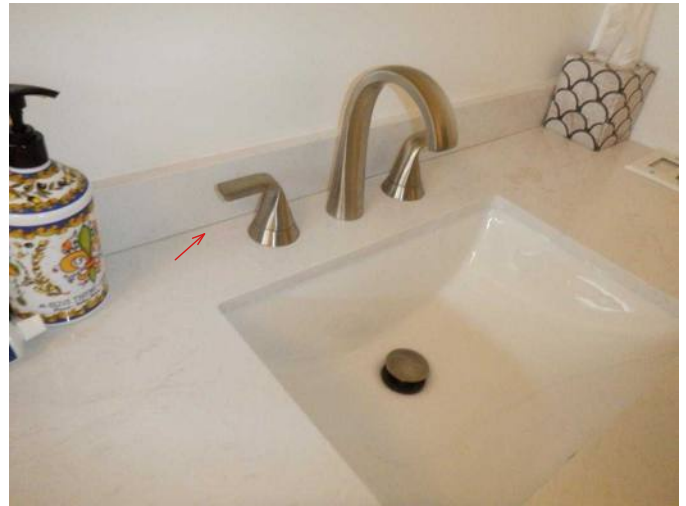
#68 Caulking needs to be redone at counter/back splash junction in first floor hall bathroom.

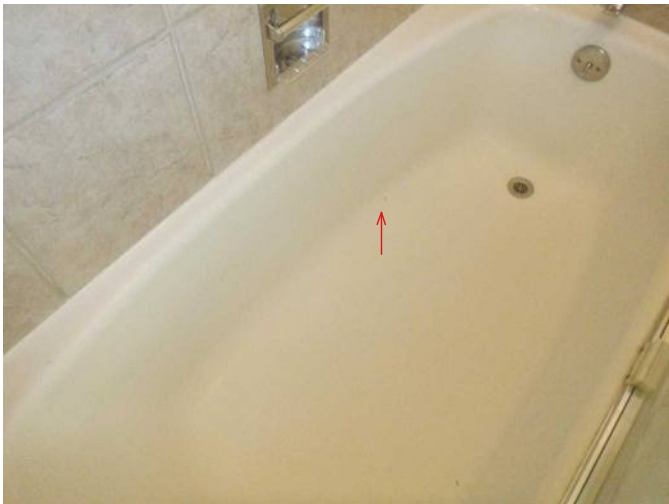
#69 Minor chips in enamel in first floor bathroom bathtub.

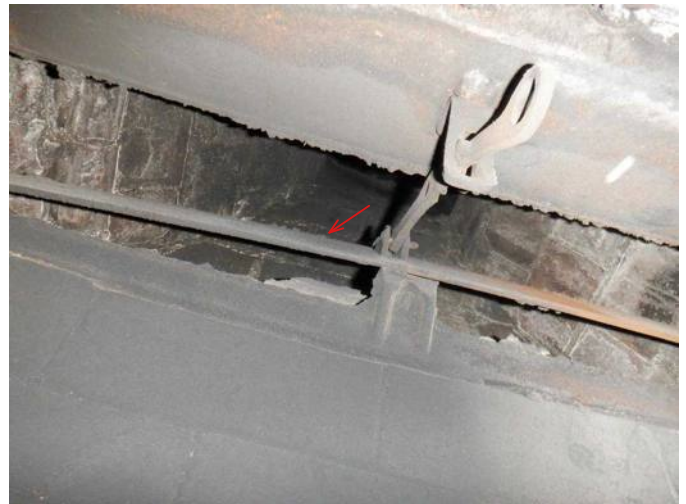
#70 Safety clamp not installed on living room fireplace damper.

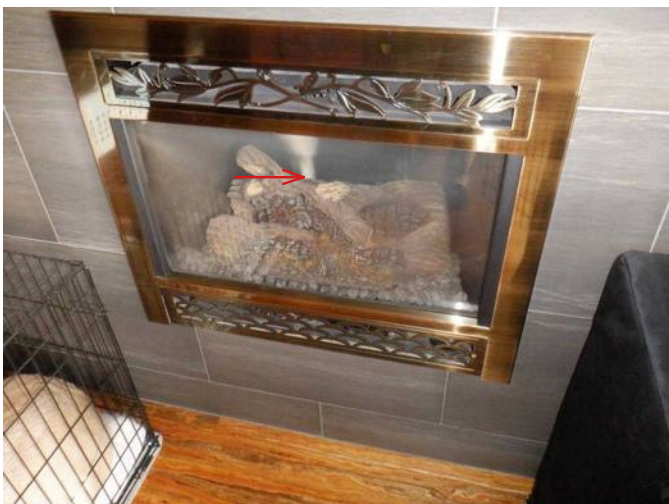
#71 Fireplace glass needs cleaning in kitchen fireplace.

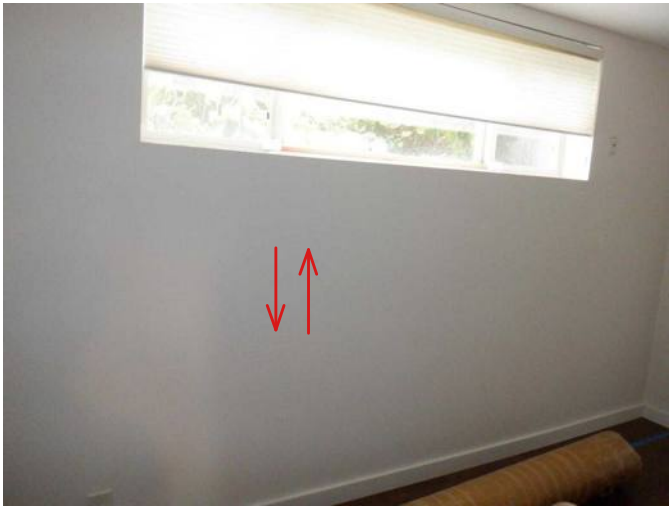
#73 Example of non egress window due to height.

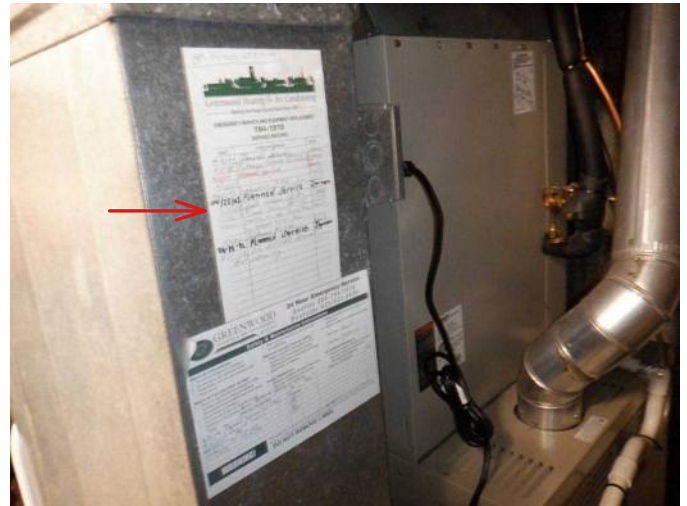
#74 Furnace is in latter third of normal life span.

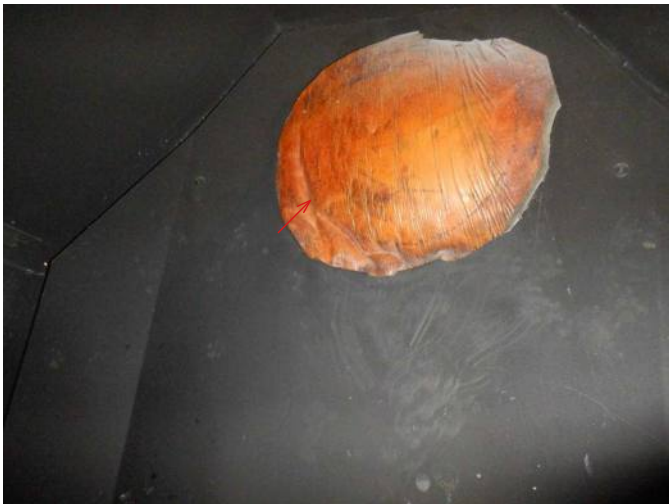
#75 Flue for family room wood stove is sealed.
