V.I. Inspections

11520 3rd Ave NW

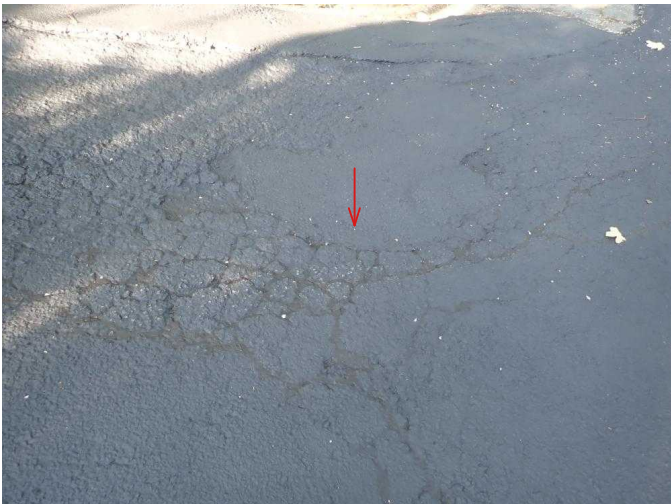
#3 Moderate cracks with moderate settling in driveway.

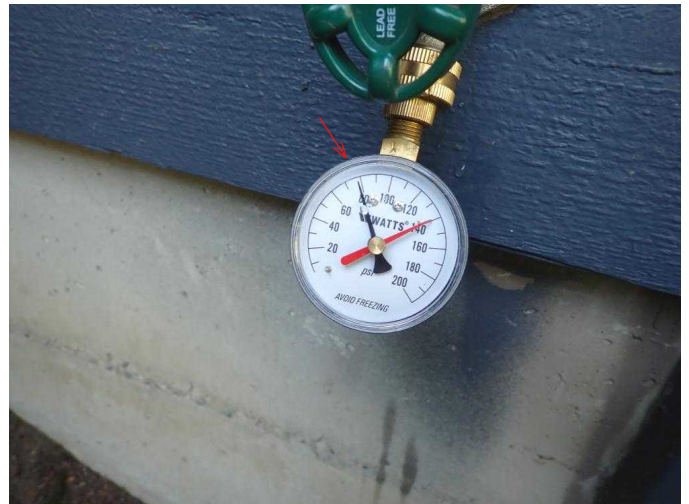
#4 Water pressure 80 psi, acceptable.

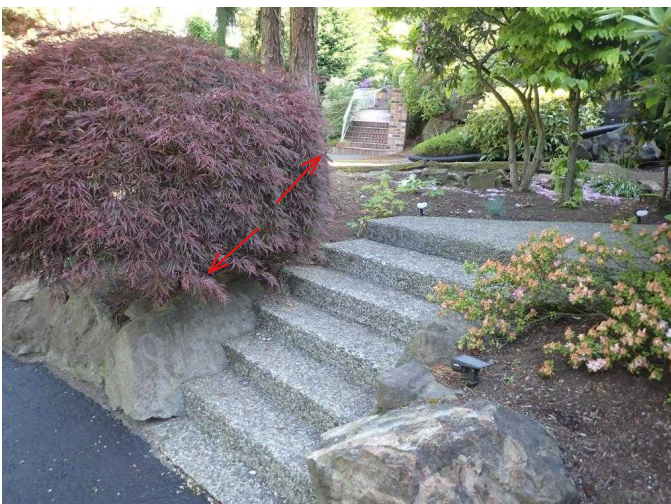
#5 No graspable handrails present on front yard access steps (safety).

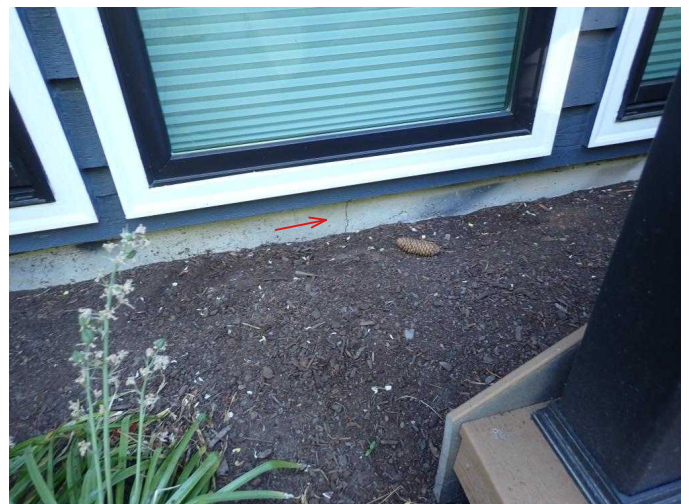
#6 Minor crack in NW foundation.

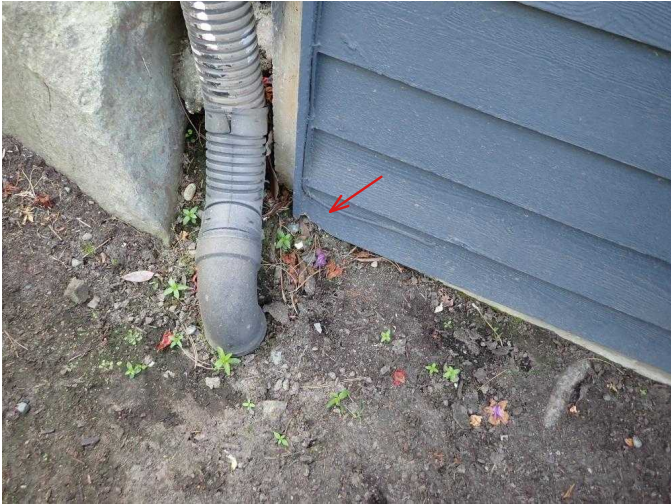
#7 Minor rot in lower NW siding where in contact with soil, soil needs to be removed.

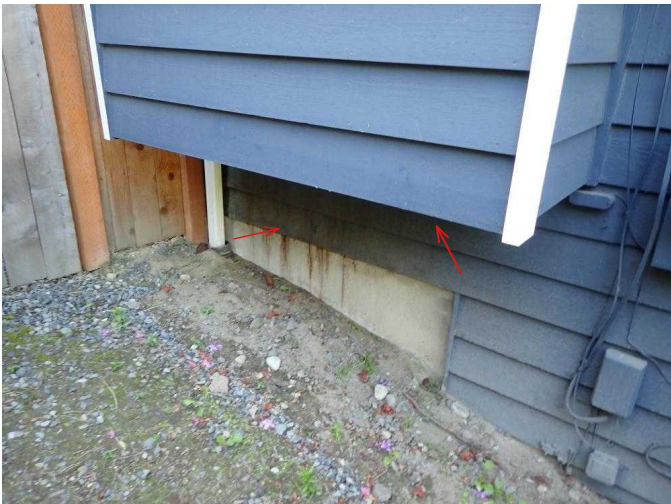
#9 High moisture reading in house siding underneath chimney and in soffit of chimney.

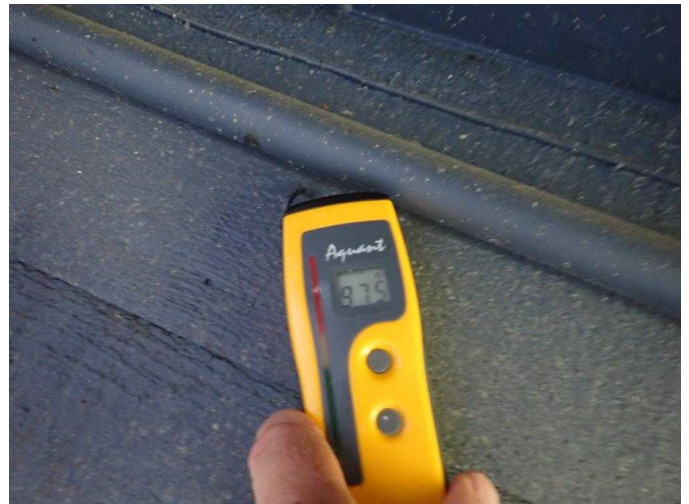
#10 High moisture reading in house siding underneath chimney and in soffit of chimney.

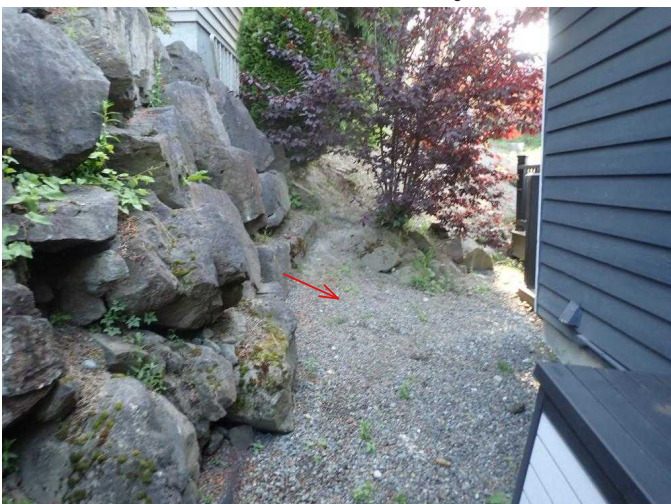
#11 NE side of property directs water run off towards house.

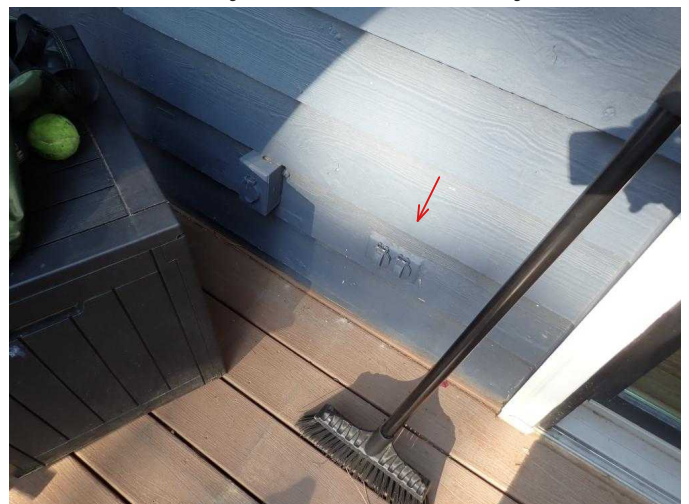
#12 Deck outlet is not GFCI protected, all exterior outlets should be GFCI protected.

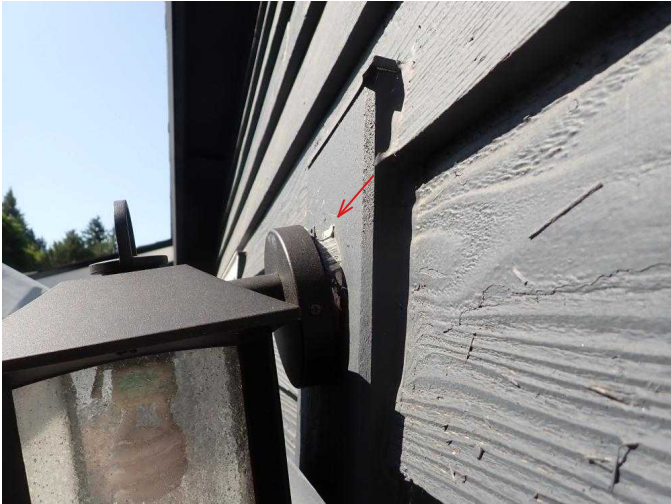
#13 Deck light fixture partially detached from base.

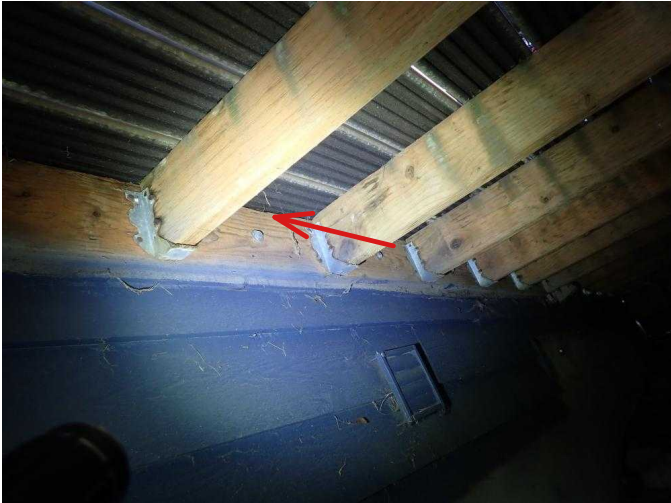
#15 Flashing not installed at house/deck junction, higher potential of moisture intrusion at deck attachment points.

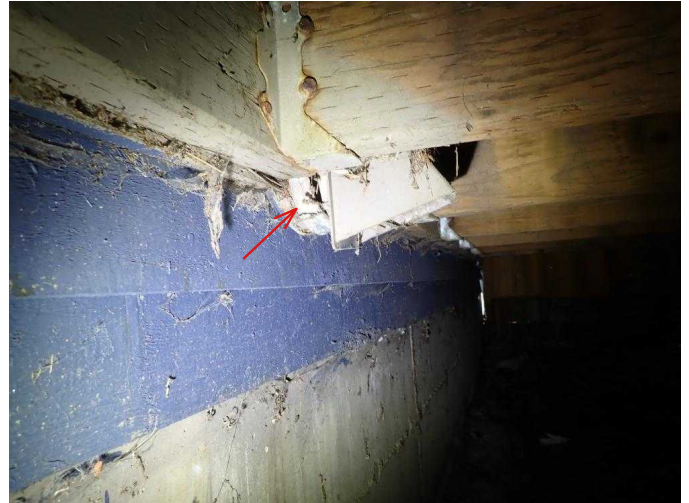
#16 Abandoned exhaust vent under deck should be sealed.

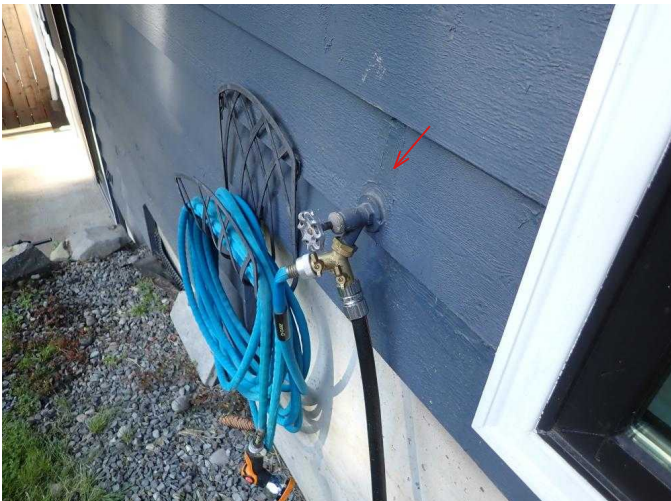
#17 Vacuum breaker not installed on E hose bib, should be installed to prevent back flow.

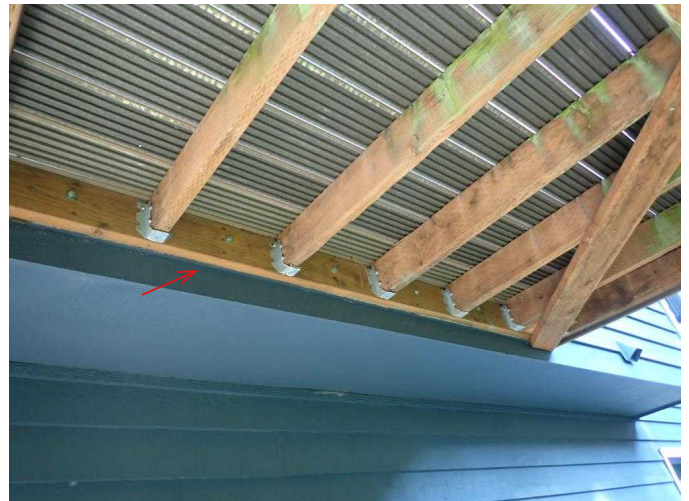
#18 Balcony installed to cantilever of house, vertical load of balcony needs to be supported.

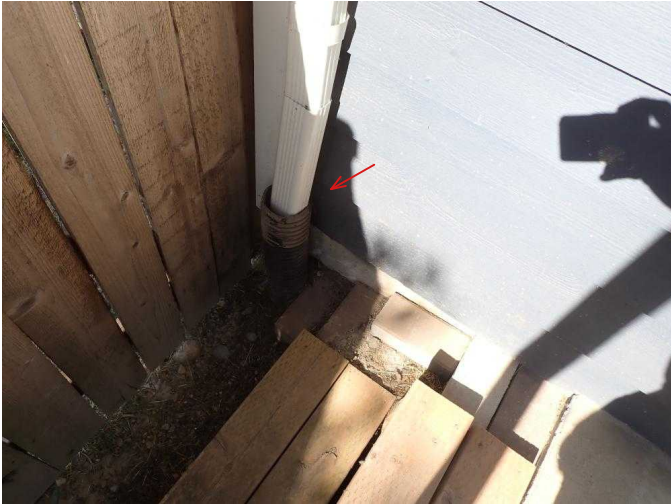
#19 Corrugated leader pipes will have a higher potential for clogging and will need to be maintained.

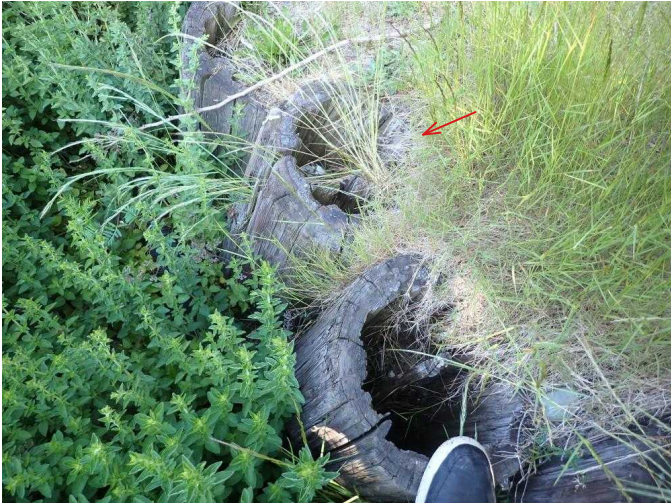
#21 Rot occurring in lower S wood retaining wall.

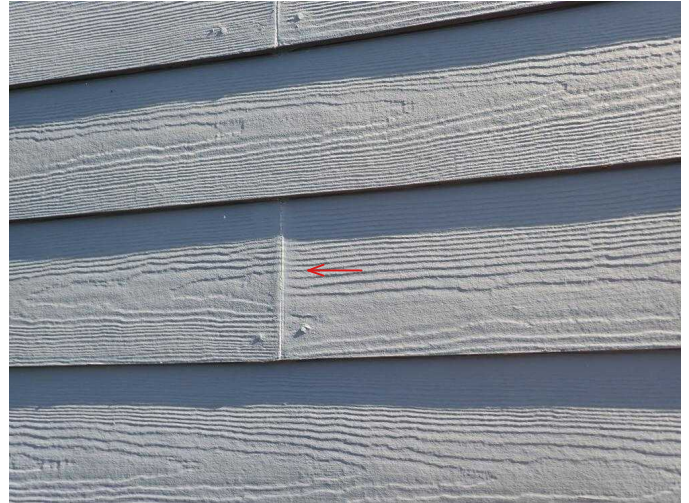
#22 No flashing at concrete lap siding butt joints, caulking will need to be maintained.

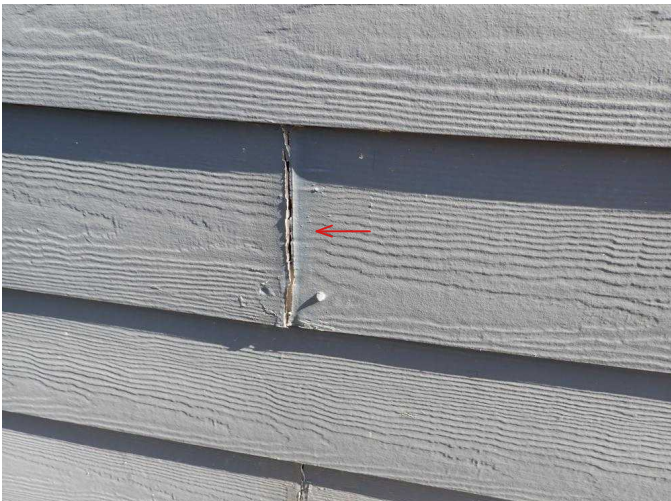
#23 Caulking cracked at some butt joints, needs to be resealed.

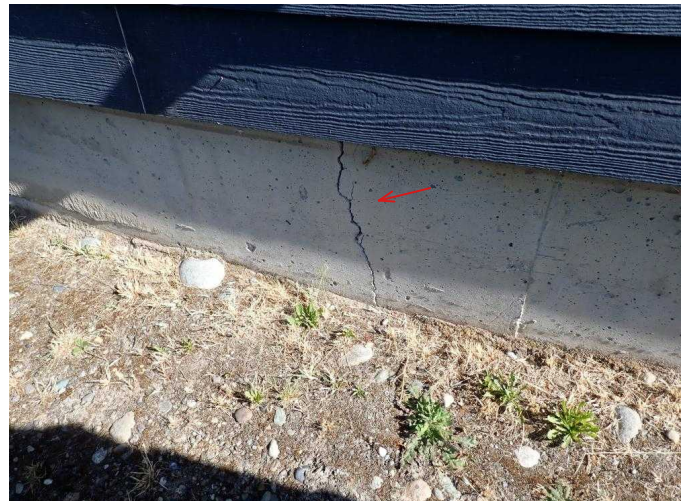
#24 Minor crack in S foundation, mid span.

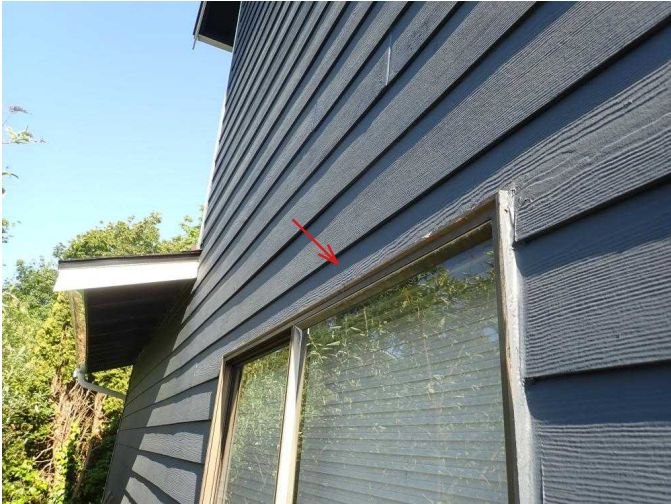
#25 No head flashing over S window.

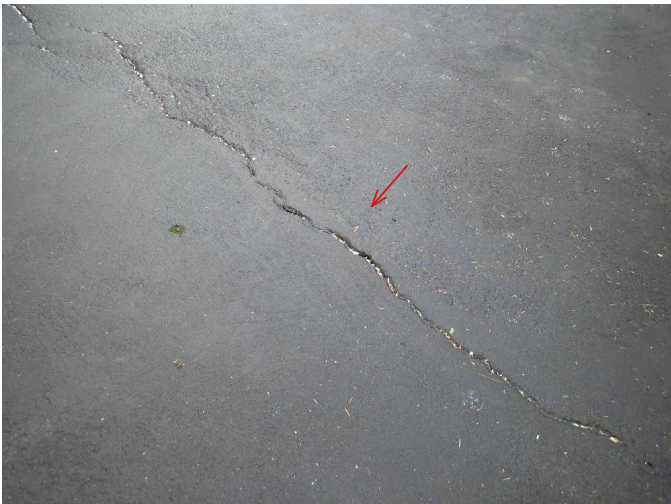
#27 Moderate cracks with moderate settling in driveway.

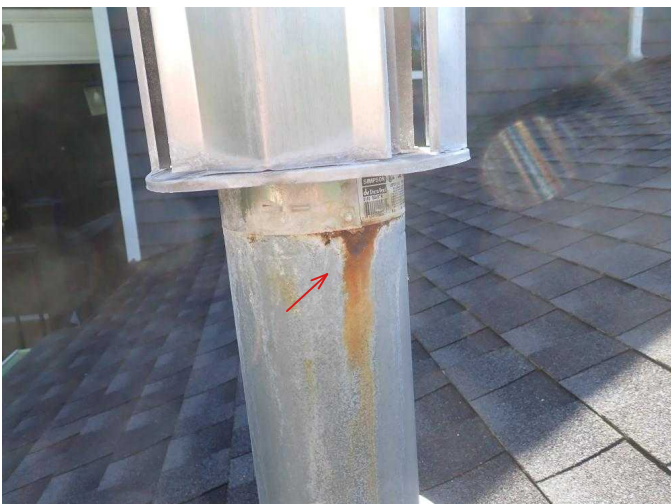
#29 Exterior section of furnace flue starting to rust and will need to be replaced in next 5 years.

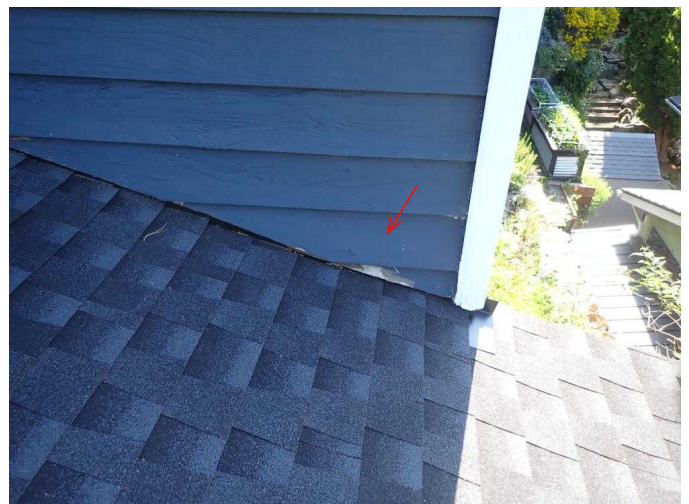
#30 Minor paint peeling on upper W siding at connection to garage.

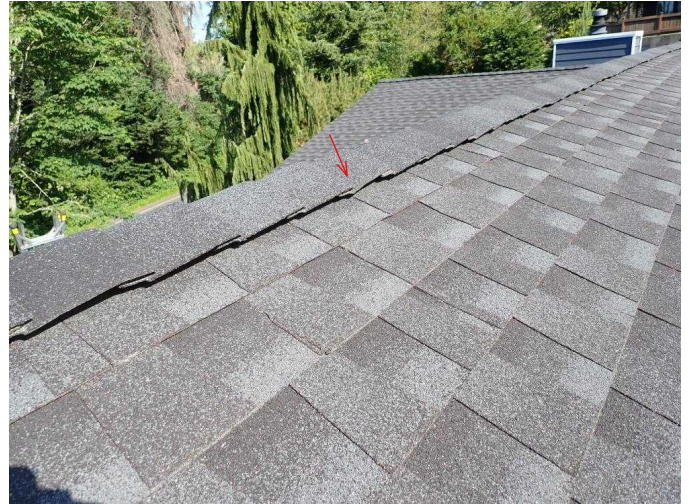
#32 Type of ridge vent installed, internally baffled, has been shown in testing to have a reduced air flow potential.

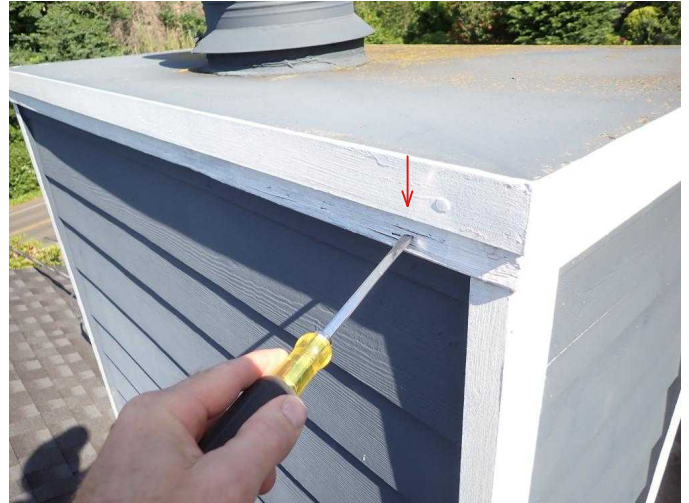
#34 Minor rot in upper trim of chimney.

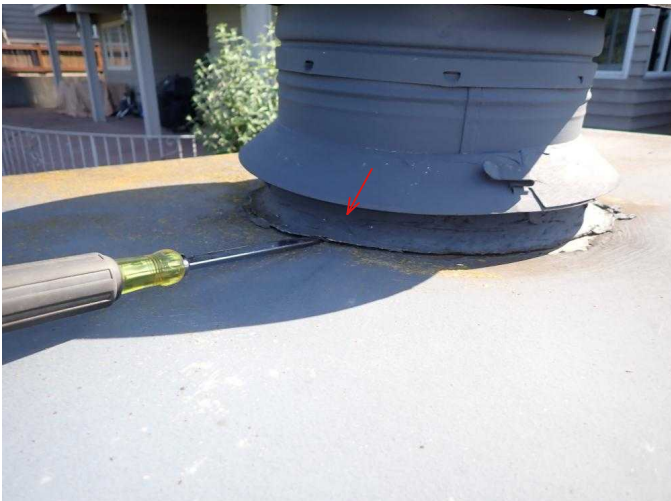
#35 Weather seal cracked around flue cap, potential water intrusion spot.

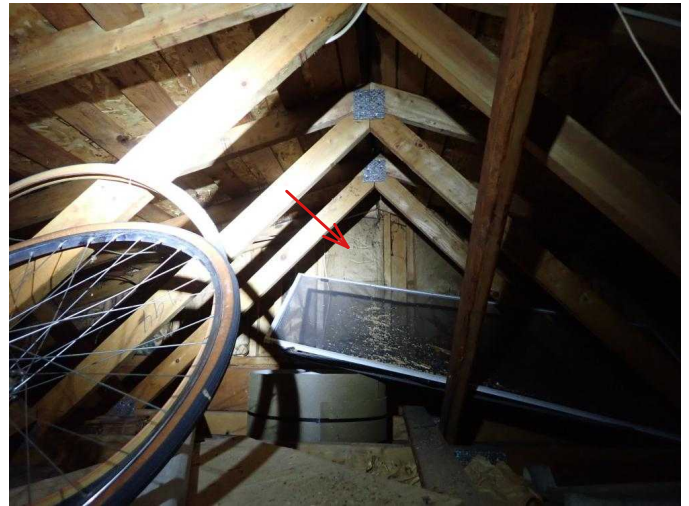
#38 Wall adjoining house in garage attic needs to be sealed against fire intrusion.

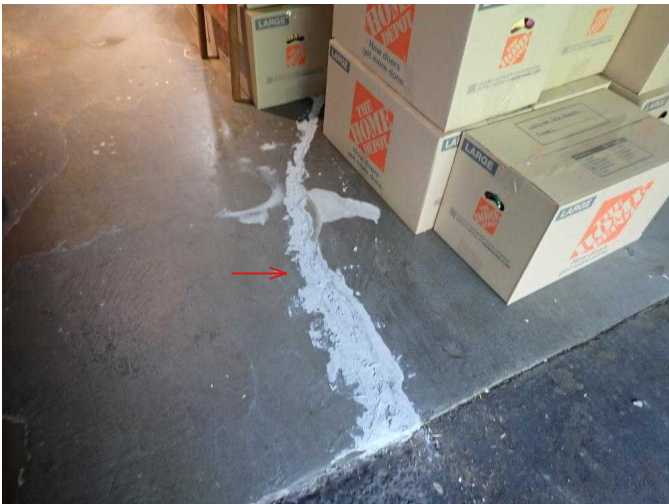
#39 Heavy crack with minor settling in SW section of floor. Crack indicates past settling, has been patched.

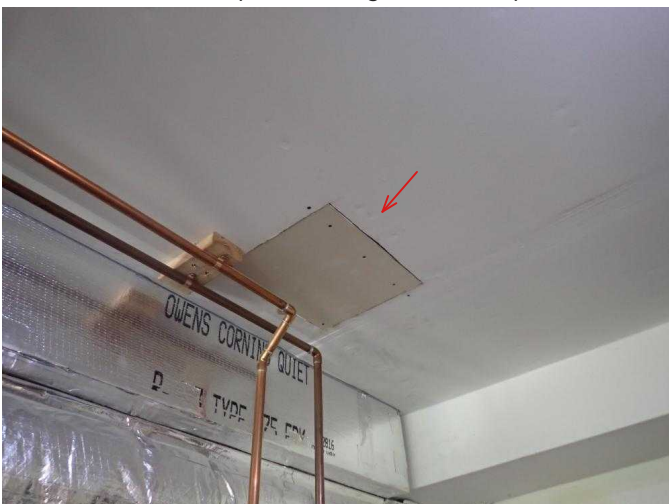
#41 All open gaps and holes in garage ceiling need to be sealed against fire intrusion.

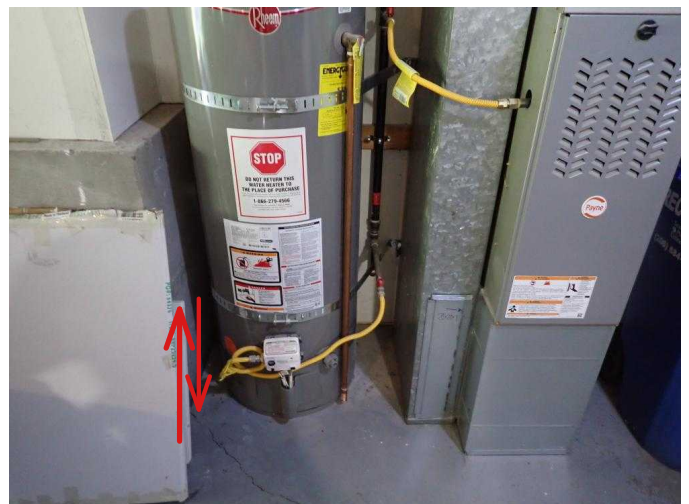
#42 Safety barrier needs to be installed in front of gas appliances to prevent potential auto impact into gas supply lines.

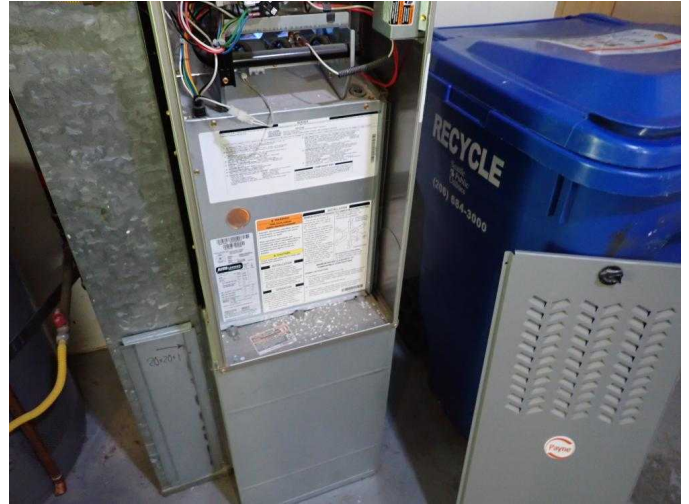
#44 No evidence of regular servicing. Furnace needs to be serviced and cleaned.

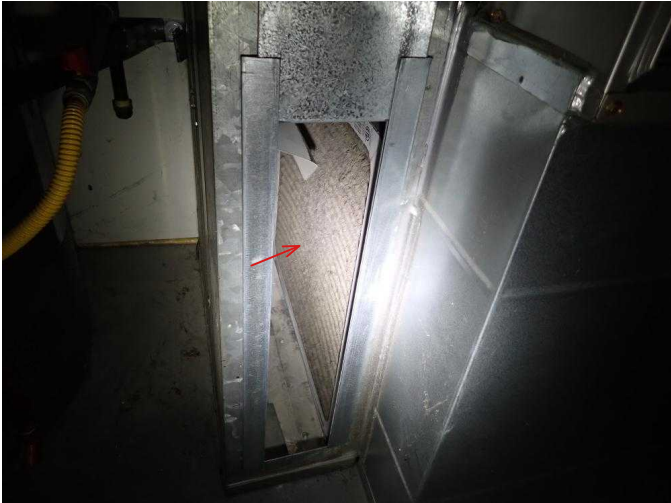
#45 Furnace filter is dirty, needs to be changed.

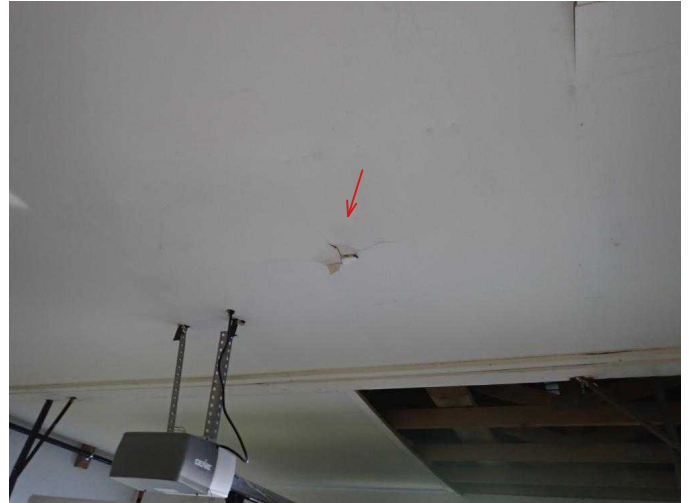
#46 Small hole in W garage ceiling.

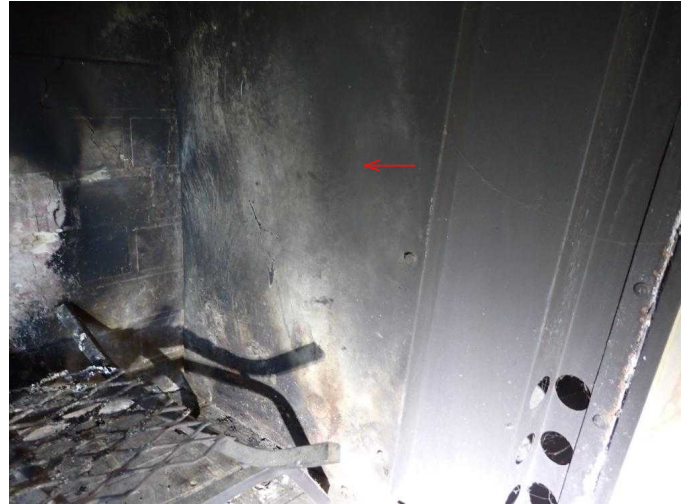
#50 Minor warping in side panels due to overheating.

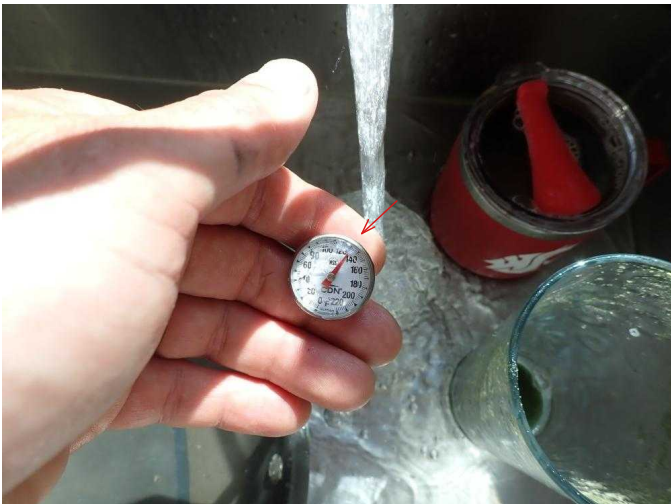
#51 Water temperature is 130 deg F, should be lowered to 120 deg F to reduce the risk of scalding.

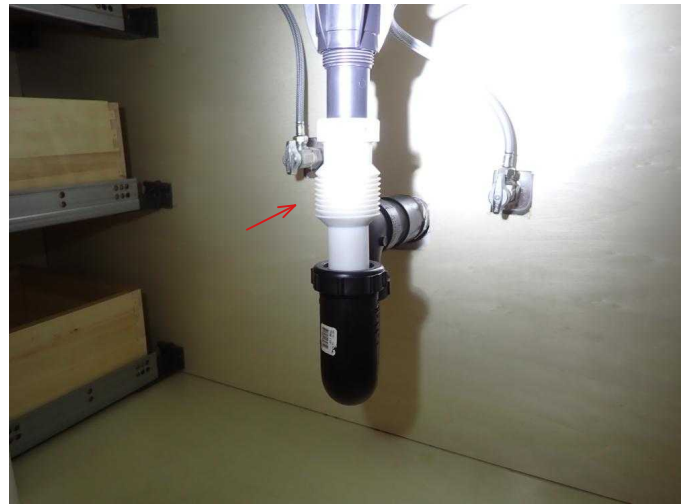
#52 Flex type drain line should be replaced with solid type drain line to reduce risk for failure/leakage.

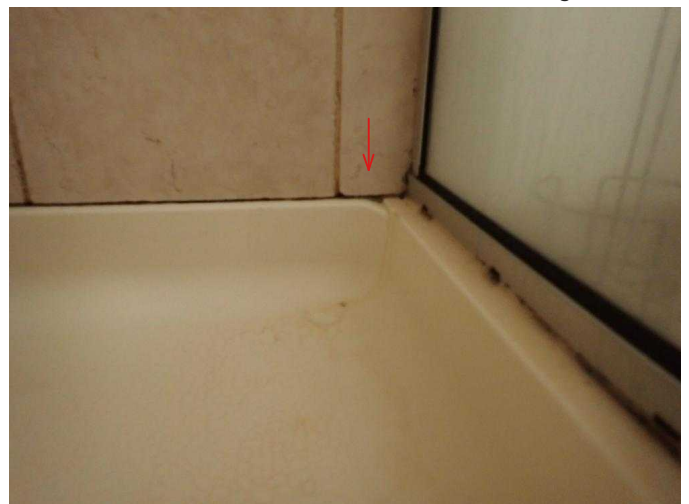
#54 Weep holes at base of primary shower surround at junction with shower pan next to door have been sealed.

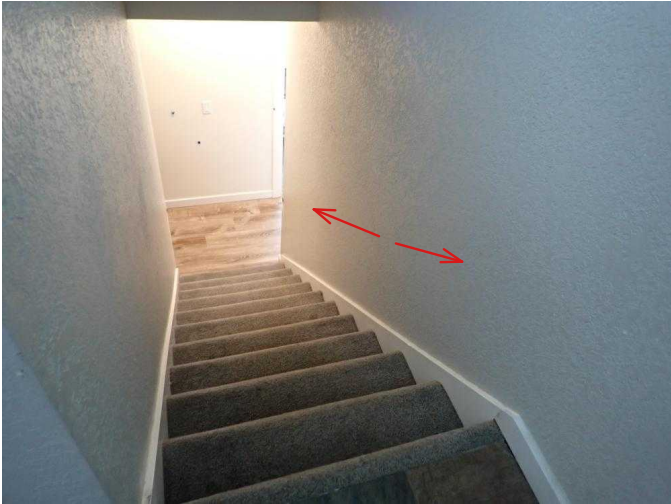
#55 No continuous graspable handrail installed (safety).

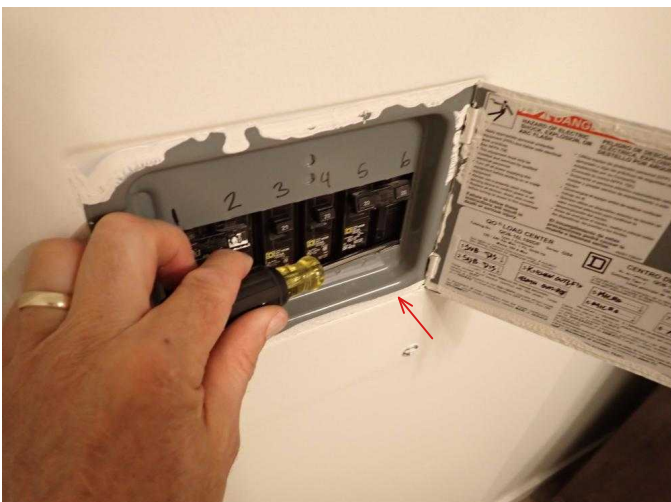
#59 Secondary electric panel is not installed flush with sheet rock causing a gap between the breakers and the panel cover.

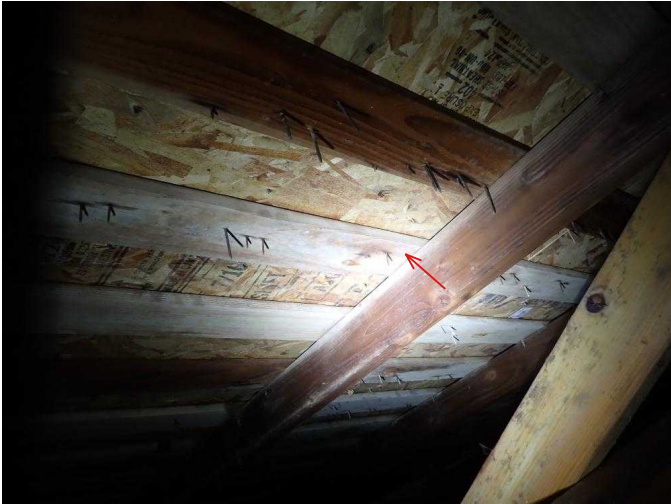
#61 Appearance of possible light vegetative haze on sections of original skip sheathing material.

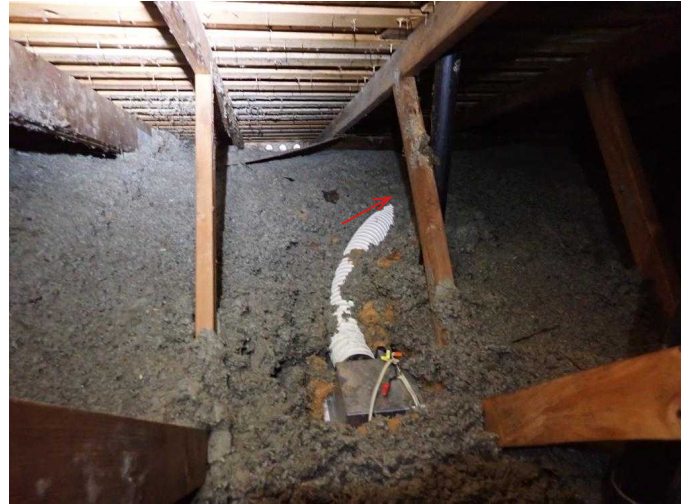
#62 Bathroom fan vents exhaust near soffit vents, need to be sealed to exterior.

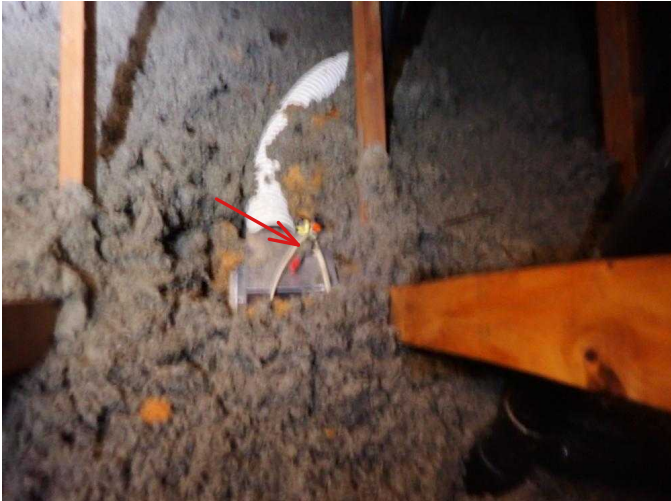
#63 Exposed wire splices at bathroom fans need to be in junction boxes.

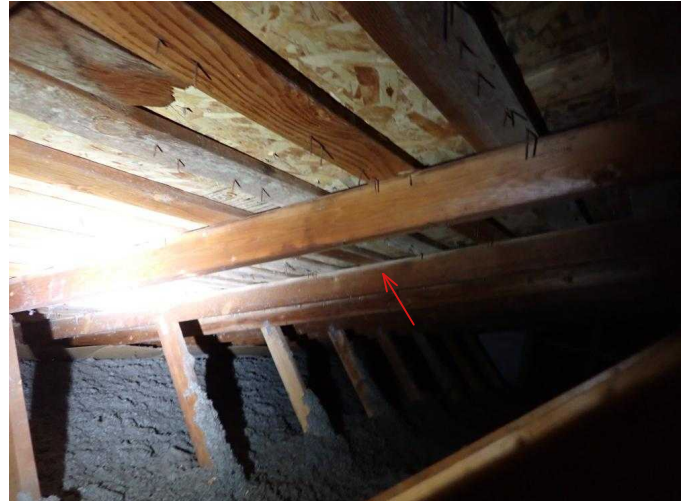
#64 Appearance of possible light vegetative haze on sections of original skip sheathing material.

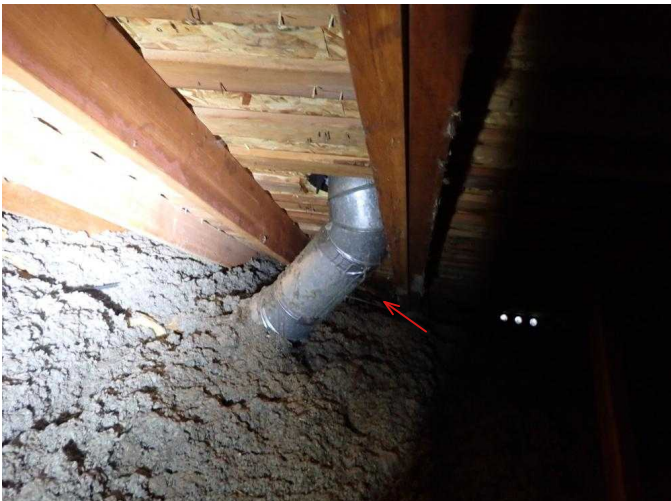
#65 Kitchen fan vent should be insulated to reduce condensation.
