Inspection report for the property at
11520 3rd Ave NW, Seattle WA 98177

This report is prepared exclusively for **Ryan Kurth and Bri Brady**
Inspected On: **06-02-2025**

Hydro Physics Pipe Inspections

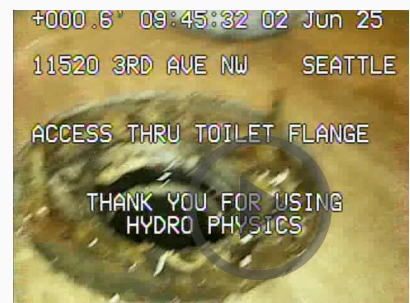
SEWER SCOPE VIDEO LINK

Here is the video recorded during your sewer scope inspection. Please contact our office if you have any questions or need assistance viewing the video.
