V.I. Inspections

1238 NW 126th St

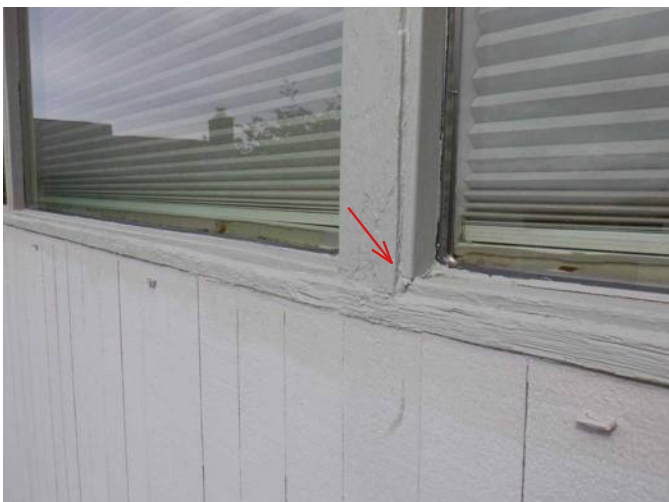
#5 Living room window trim moderately weathered.

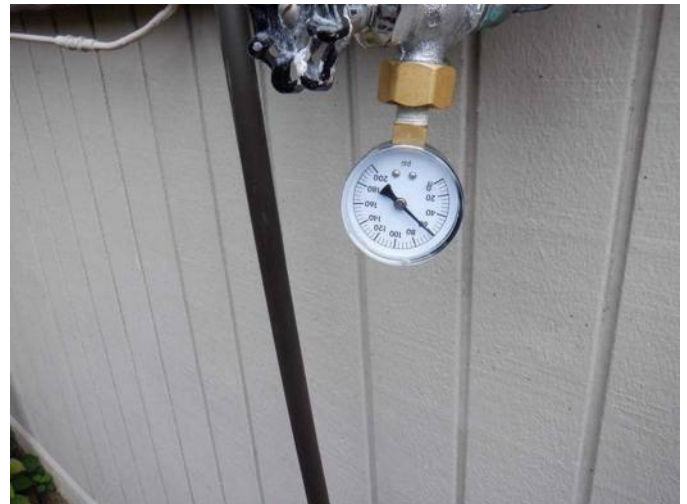
#10 Water pressure tested at 60 psi.

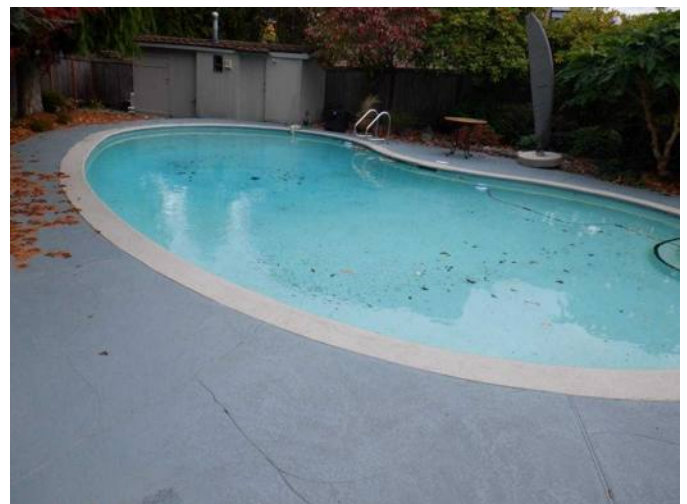
#12 Swimming pools and swimming pool equipment are outside scope of home inspection, not inspected.

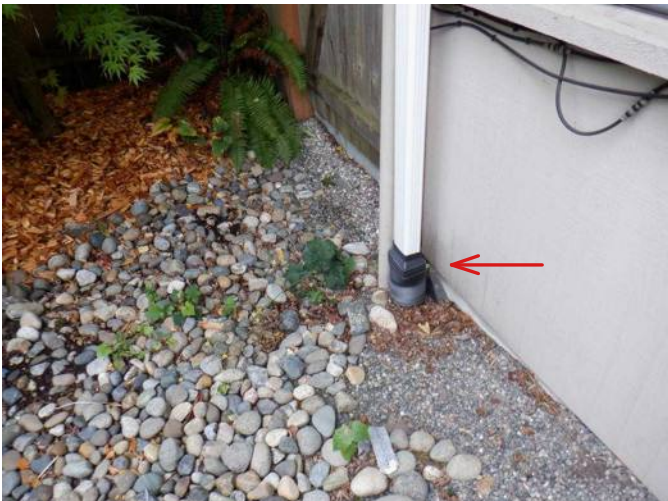
#23 Plastic corrugated pipe used as leader system has a higher potential for clogging, will need to be maintained.

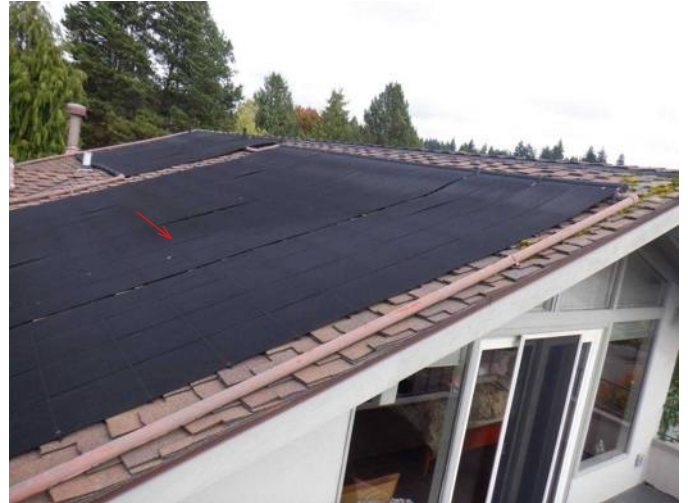
#34 Pool solar heater system, not inspected.

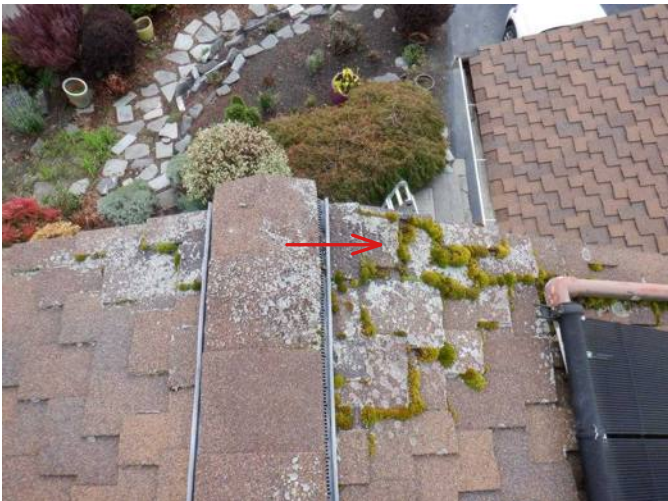
#35 Minor moss build up should be removed and moss will need to be maintained off of roof surface.

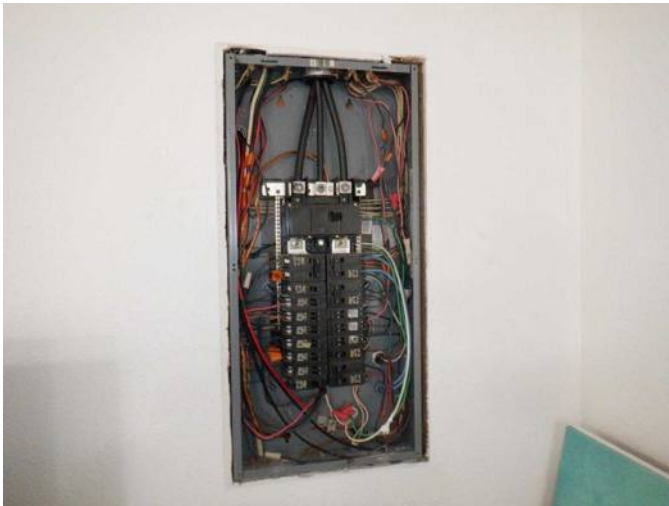
#43 Electric panel located in the family room.

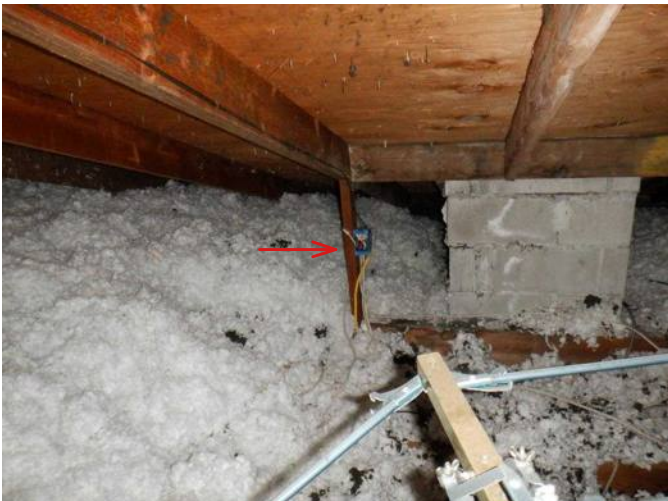
#53 Open junction boxes in lower attic need cover plates.

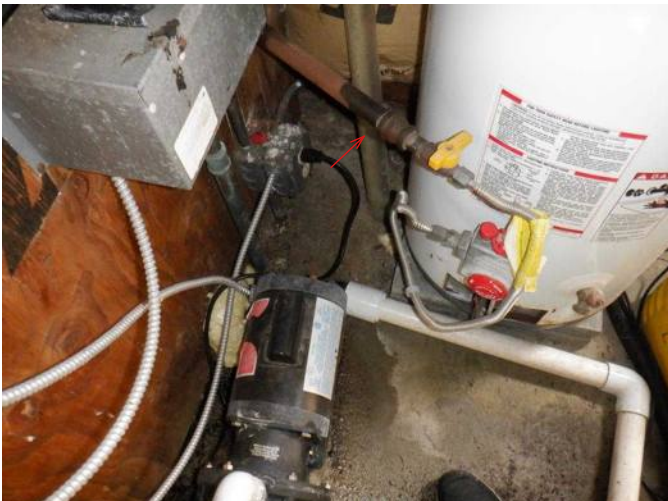
#59 No sediment leg for gas line to outbuilding water heater.

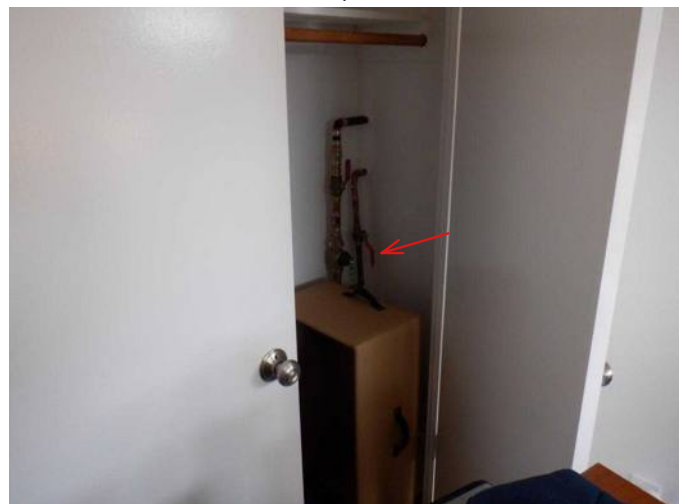
#72 Water main shut off valve located in the SE basement bedroom closet.
